Heritage Structure Assessment

This assessment is the resulting product of a heritage study on bridge structures in the City of Hamilton. The study and the assessment were conducted from May to August 2002. The aim was to establish a heritage record for all bridge structures over the age of 35 years. The assessment is a required component of the Class Environmental Assessment that will be conducted on the city's bridge structures later in 2002. The Environmental Assessment Act mandates the heritage data will be considered in any final decisions that may impact the nature of a structure.

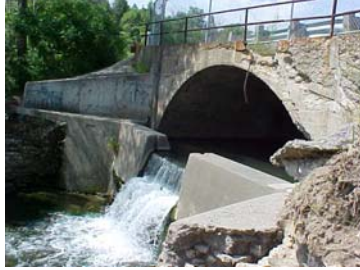
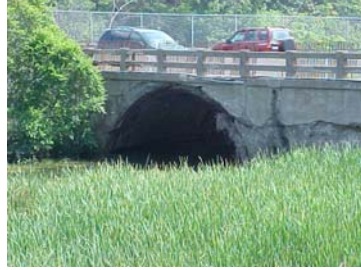
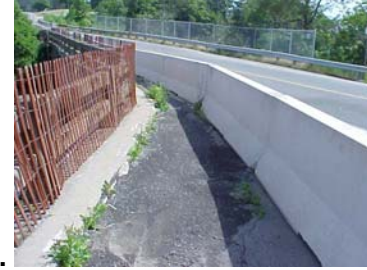
Construction material(s) and Details: This concrete arch has a simple, decorative balustrade and stepped wing walls. The date the wing walls were refurbished is stamped on the northeast side. The structure is in very poor condition. There are large cracks in the structure and sections of the balustrade are seriously damaged.

Integrity: The wing walls of the structure were refurbished or replaced entirely in 1984. This date is stamped on the existing wing walls. Temporary measures have been erected to ensure safety on the structure. Temporary fencing and barriers prevent access to the balustrade. There is no obvious evidence of alteration, but it is assumed that some sympathetic modifications have occurred.

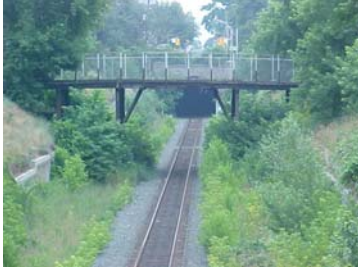
1.

Construction material(s) and Details: This wooden trestle has been closed to vehicle traffic and shows signs of much deterioration. The deck is fenced in, except for a small pedestrian walkway.

Photos: 1) West face
2) Deck surface
3) Closed Deck

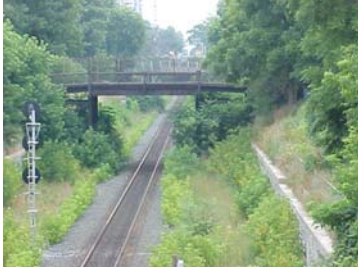
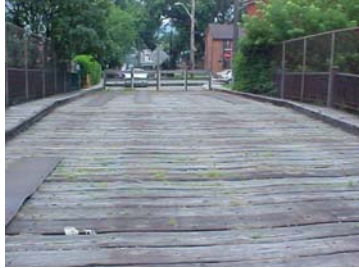
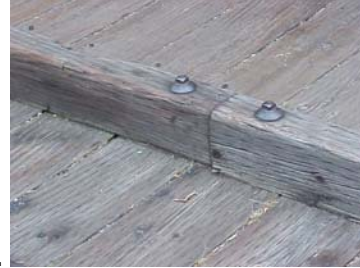
Construction material(s) and Details: This wooden trestle has been closed to vehicle traffic and shows signs of much deterioration.

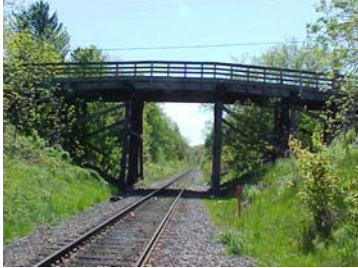
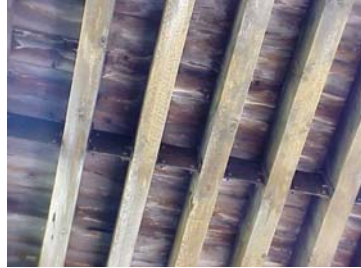
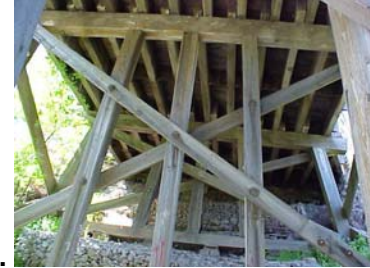
Construction material(s) and Details: This wooden trestle shows little sign of deterioration in its piers, balustrade, or deck.

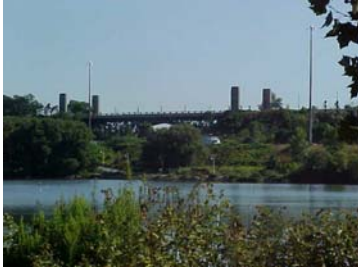
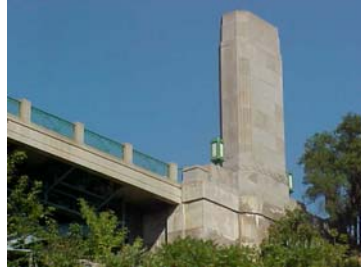
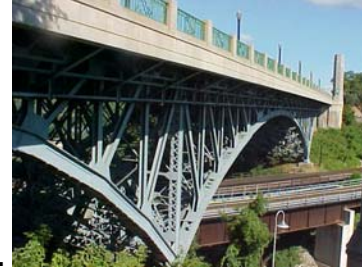
Construction material(s) and Details: This steel and concrete structure is heavily decorated and shows few signs of deterioration. The massive pylons at both end of the structure are decorated with the City's coat of arms.

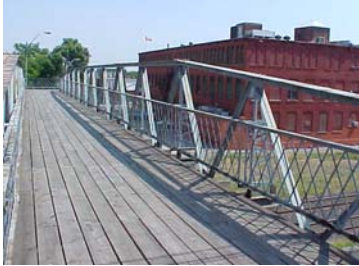
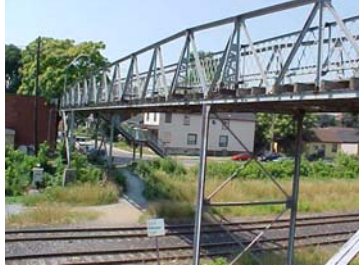
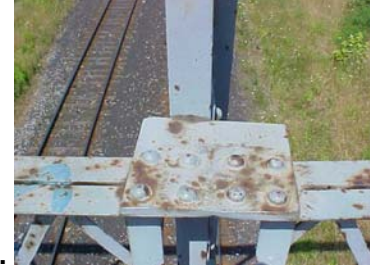
Bridge type: Truss
Bride Management System Subtype: Half-Through Truss
No. of spans: 3
Construction period: 1940-1955
Date if known: 1915
Builder/engineer if known:
Construction material(s) and Details: Steel piers support this steel truss, which is riveted together. The timber deck is in good condition while the steel shows some signs of deterioration.
Integrity: There is no evidence of alteration.
Historical associations: This structure was constructed as a replacement to the previously existing foot bridge, which was deemed unsafe by the city in 1946. Much debate surrounded the design of the predecessor. Local residents wanted a road bridge constructed, as traffic cannot travel north bound on Emerald Street because of the tracks. The city would not allow a road bridge or a level-cross to take the former bridge's place. Therefore, this steel footbridge was decided upon.
Notes: This structure scored respectably. The age, integrity, and historical associations of this structure raised its heritage value. The scarcity of this design type contributed to the heritage value of this structure.

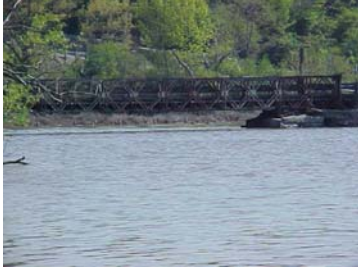
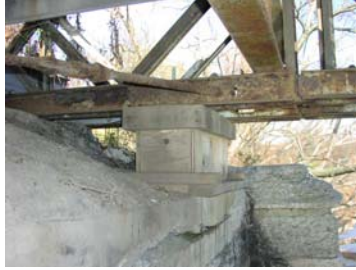
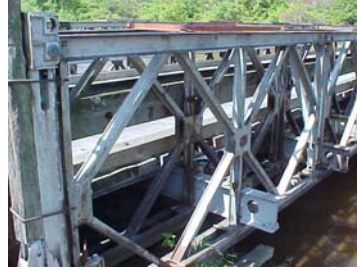
Construction material(s) and Details: This bailey structure consists of connecting steel panels that support a timber deck. It rests on concrete abutments. There is much deterioration to the structure.

Integrity: The deck has been sympathetically replaced.

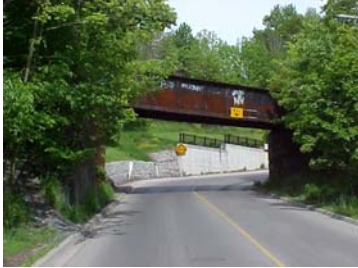
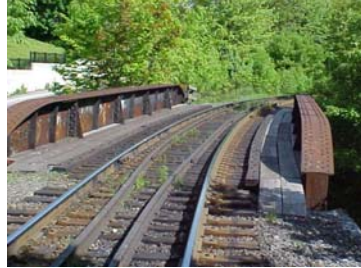
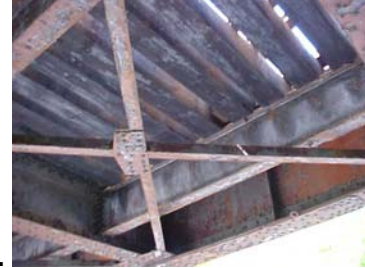
Construction material(s) and Details: Concrete abutments support this steel structure. The construction date is imprinted in the abutment. There are some signs of deterioration to the structure. Under the tracks on the deck surface is a base of timber beams.

Integrity: There is no sign of adverse alteration. However, the timbers on the deck appear to have been replaced.

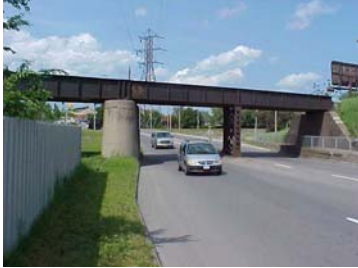
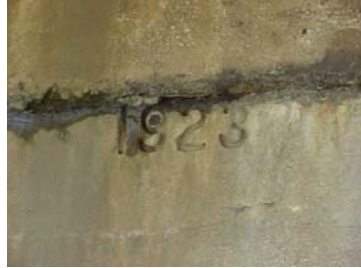
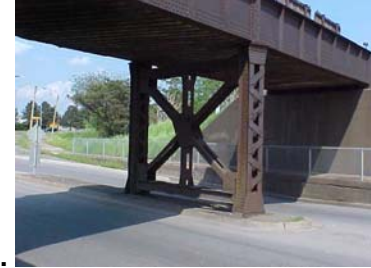
Construction material(s) and Details: Steel and concrete piers support this multi-span steel structure. The steel and concrete components of this structure show few signs of deterioration. The construction date is imprinted in the east deck face. This box-girder style of rail structures is not commonly found throughout the city of Hamilton. Similar to the wooden trestle, they are perceived as an obsolete design type and are threatened with dismantling.

Photos: 1) South face
2) Date imprint
3) Pier

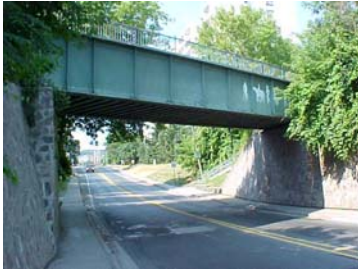
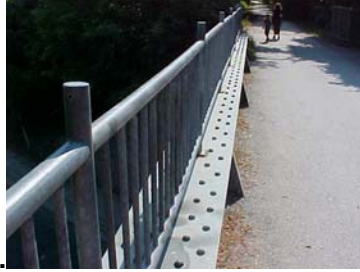
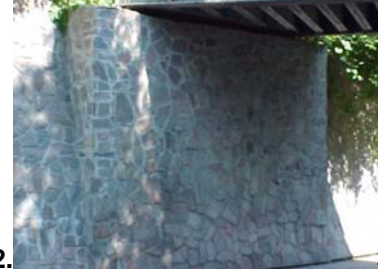
Bridge type: beam
Bride Management System Subtype: half-through beams
No. of spans: single
Construction period: 1901-1939
Date if known:
Builder/engineer if known:
Construction material(s) and Details: This steel structure has been refurbished. The abutments have been decorated. The former railway has been converted to a pedestrian trail.
Integrity: The structure has been refurbished sympathetically.
Historical associations: The structure would have been originally constructed to serve the T.H. & B. rail line. It has since been developed into a section of the Rail Trail.
Notes: This structure was scored as having moderate heritage value. The box-girder style of rail structure was identified in this study as being rare as a survivor, as there are few still in existence in the Hamilton area. This structure also score well because of its integrity, and age.
Documentation: A written record for the structure was not located.

Photos: 1) North face
2) Looking east
3) Abutment decoration

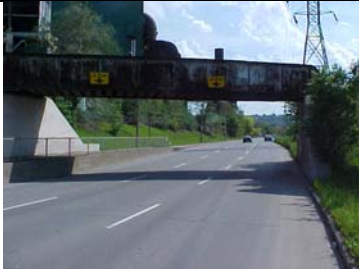
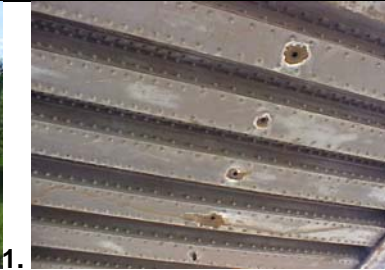
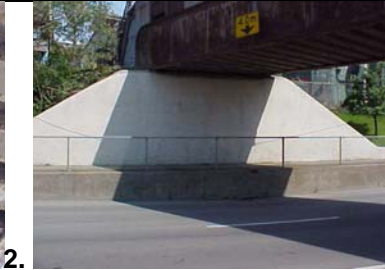
Construction material(s) and Details: This single span steel structure shows signs of deterioration. This box-girder design type is scarce though out the city of Hamilton. Similar to the wooden trestle, they are perceived as an obsolete design type and are threatened with dismantling

Photos: 1) North face
2) Underside of deck
3) East abutment

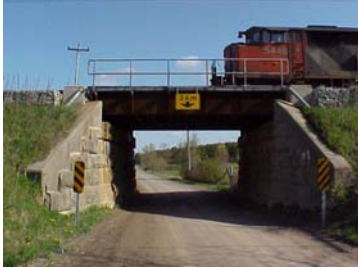
1.

Construction material(s) and Details: Stone abutments support steel beams over the roadway. The abutments are rock-faced and extend into perpendicular wing walls. There is some deterioration to both the steel and stone components of this structure.

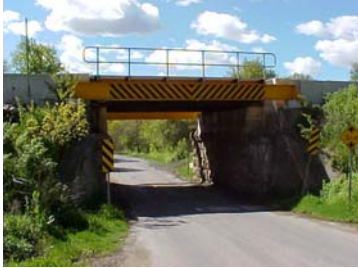
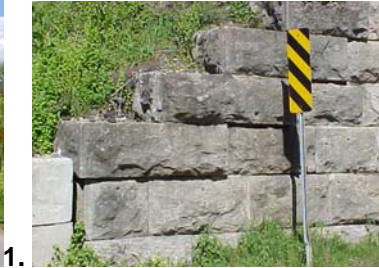
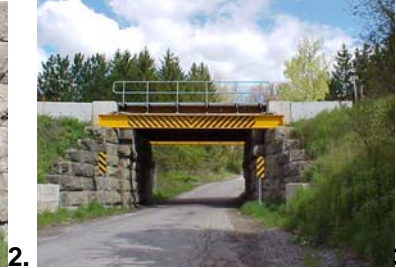
Asset/Bridge ID: 37-201
Street and crossing: Weirs Ln. - Former Grand Trunk Rail line
Former Municipality(ies): Flamborough
UTM reference: E:N/A
N:N/A
Date of survey: 21/05/02
Built heritage inventory file no: 60237
Heritage Evaluation Score and Grade: 56,B

Construction material(s) and Details: Stone abutments support steel beams over the roadway. The abutments are rock-faced and extend into perpendicular wing walls. There is some deterioration to both the steel and stone components of this structure.

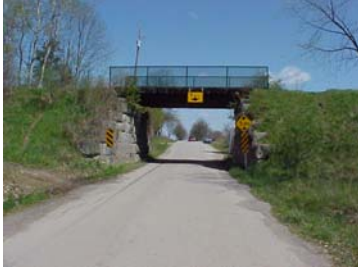
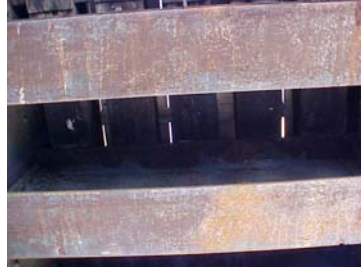
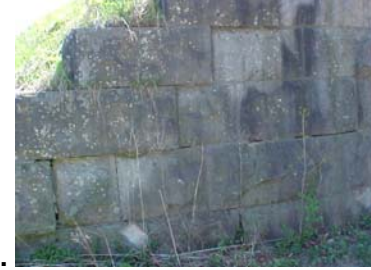
Heritage Evaluation Score and Grade: 57,B

Construction material(s) and Details: Stone abutments support steel beams over the roadway. The structure has been converted to support a pedestrian trail. There is some deterioration to both the steel and stone components of this structure.

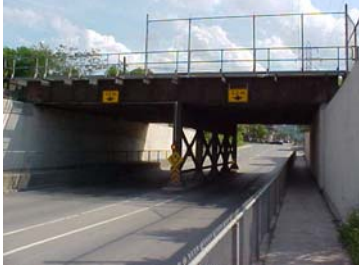
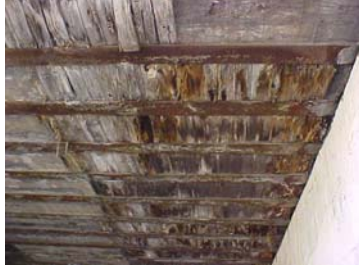
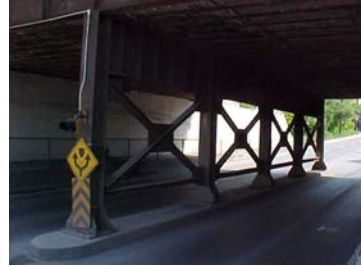
Asset/Bridge ID: 332-1016
Street and crossing: Birch-C.N. line
Former Municipality(ies): Hamilton
UTM reference: E:594280
N:4791400
Date of survey: 05/06/02
Built heritage inventory file no: 602332
Heritage Evaluation Score and Grade: 40,C

Construction material(s) and Details: This simple continuous span steel structure shows signs of deterioration. The underside of the deck shows the remains of timber.

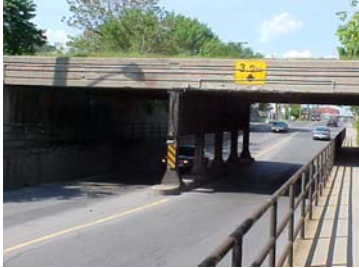
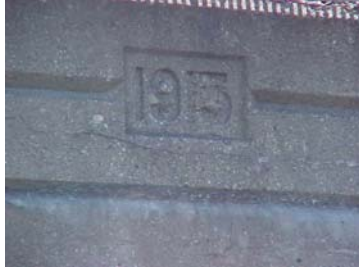
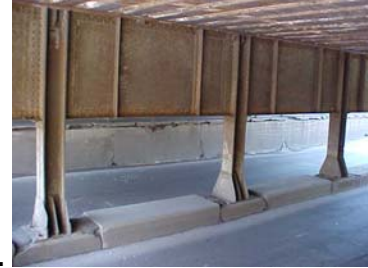
Asset/Bridge ID: 247-1072
Street and crossing: Kenilworth-Former GW.R. line
Former Municipality(ies): Hamilton
UTM reference: E:597030
N:4789550
Date of survey: 06/06/02
Built heritage inventory file no: 602247
Heritage Evaluation Score and Grade: 43,C

Construction material(s) and Details: Steel piers support this continuous span steel structure. The steel and concrete components of this structure show signs of deterioration. The construction date is imprinted in the north deck face. There are decorative cuts in the concrete components of the deck.

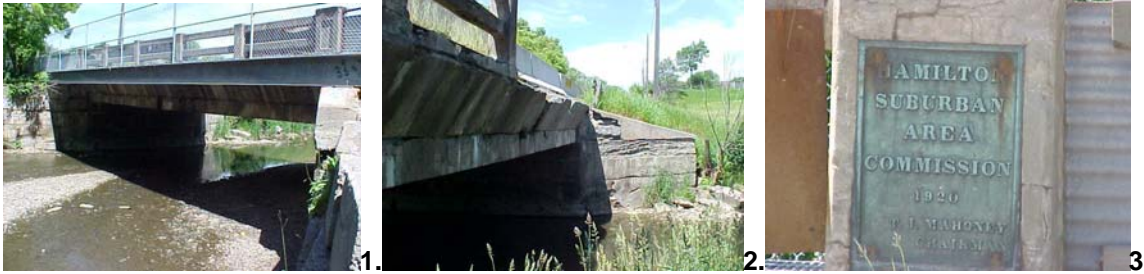
Asset/Bridge ID: 86-1513
Street and crossing: Melvin – Red hill Creek
Former Municipality(ies): Hamilton
UTM reference: E: 599580
N: 4788190
Date of survey: 18/06/02
Built heritage inventory file no: 60186
Heritage Evaluation Score and Grade: 28,D

Bridge type: beam
Bride Management System Subtype: T-beams
No. of spans: single
Construction period: 1901-1939
Date if known: 1920
Builder/engineer if known:

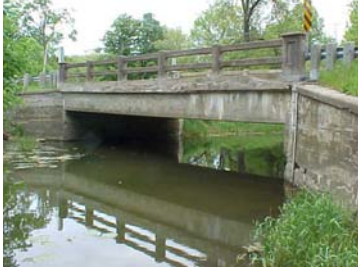
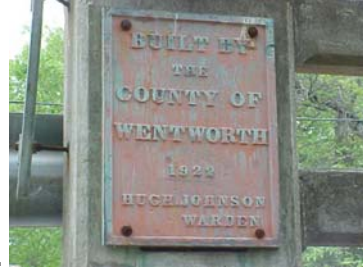
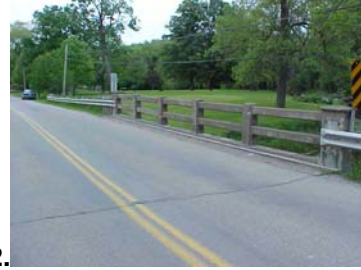
Asset/Bridge ID: 118-6001
Street and crossing: Woodburn – Twenty Mile Creek
Former Municipality(ies): Glanbrook
UTM reference: E:602060
N:4776490
Date of survey: 04/06/02
Built heritage inventory file no: 601118
Heritage Evaluation Score and Grade: 40,C

Construction material(s) and Details: This concrete beam structure has a concrete balustrade. A plaque is mounted on this balustrade. The structure shows some signs of deterioration.

Photos: 1) south face
2) plaque- northeast balustrade
3) north balustrade

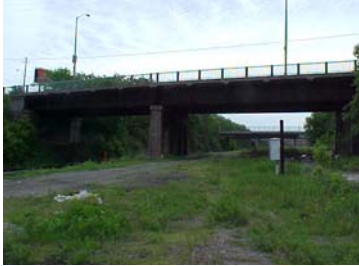
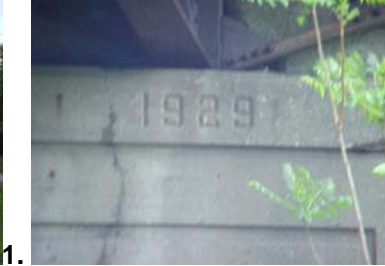
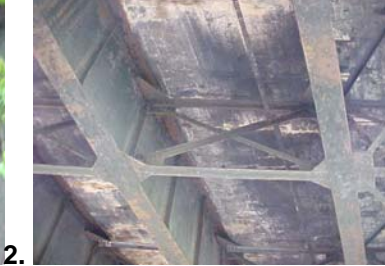
Asset/Bridge ID: 185-1007
Street and crossing: Bay-Former GW.R. line
Former Municipality(ies): Hamilton
UTM reference: E:591860
N:4791110
Date of survey: 06/06/02
Built heritage inventory file no: 602185
Heritage Evaluation Score and Grade: 53,C

The steel and concrete components of this structure show signs of deterioration. The construction date is imprinted in the north deck face. There are decorative cuts in the concrete components of the deck. The underside reveals timbers that exist below the concrete deck surface.

Photos: 1) West face
2) Date imprint
3) Underside of deck

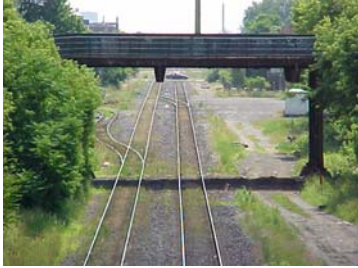
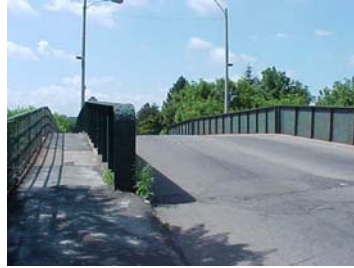
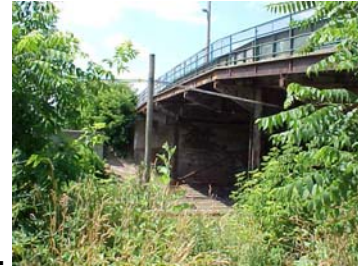
Asset/Bridge ID: 180-1092
Street and crossing: Mary Street- CN
Former Municipality(ies): Flamborough
UTM reference: E: 592590
N: 4790930
Date of survey: 4/7/02
Built heritage inventory file no: 602180
Heritage Evaluation Score and Grade: 53,C

Photos: 1) West face
2) Looking south-deck surface
3) Looking southwest-superstructure

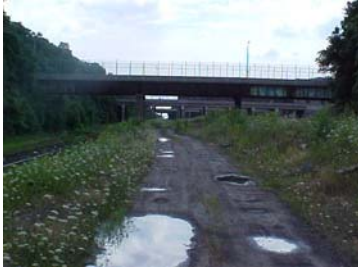
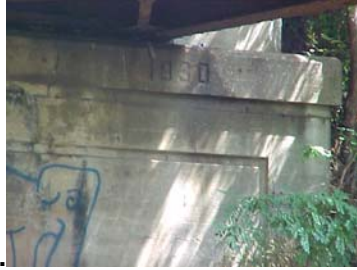
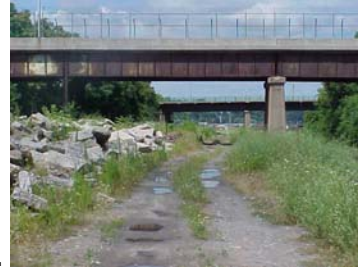
Asset/Bridge ID: 184-1085
Street and crossing: MacNab-Former GW.R. line
Former Municipality(ies): Hamilton
UTM reference: E:592000
N:4791058
Date of survey: 20/08/02
Built heritage inventory file no: 602184
Heritage Evaluation Score and Grade: 58,B

Construction material(s) and Details: Steel and concrete piers support this multi-span steel structure. The concrete and steel components of this structure show signs of deterioration. The construction date is imprinted in the north abutment.

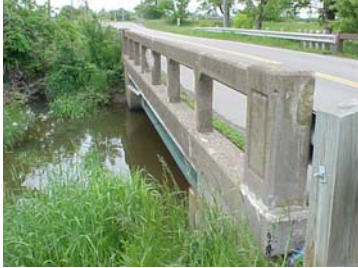
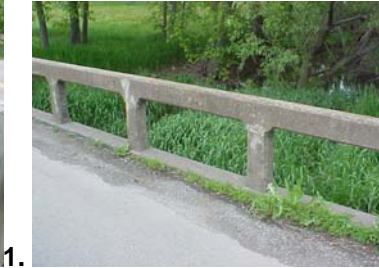
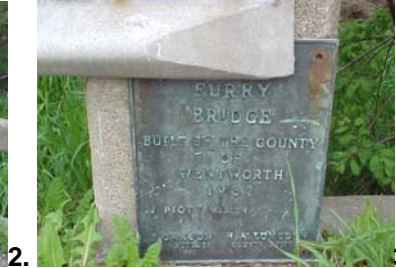
Asset/Bridge ID: 150-4004
Street and crossing: Tapleystown Rd. –Stoney Creek
Former Municipality(ies): Hamilton
UTM reference: E: 603770
N: 4783115
Date of survey: 06/06/02
Built heritage inventory file no: 601150
Heritage Evaluation Score and Grade: 41,C

Construction material(s) and Details: Steel beams support the concrete deck of this structure. There is simple concrete balustrade on the deck. There is a small plaque on the balustrade. There are some signs of deterioration to all components of the structure.

3) Plaque – south west balustrade

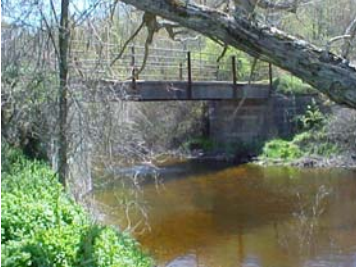
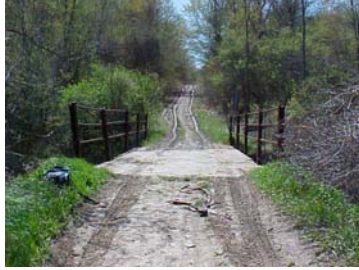
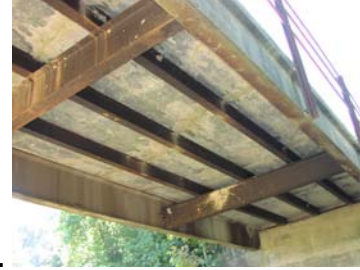
Asset/Bridge ID: 33-103
Street and crossing: Weir Rd. – Barlow Creek
Former Municipality(ies): Flamborough
UTM reference: E:566230
N:4790505
Date of survey: 10/05/02
Built heritage inventory file no: 60133
Heritage Evaluation Score and Grade: 35,D

Construction material(s) and Details: Concrete abutments support this steel and concrete structure. There is much deterioration present at this site. This structure is located on an inactive road.

3) underside-BMS file photo

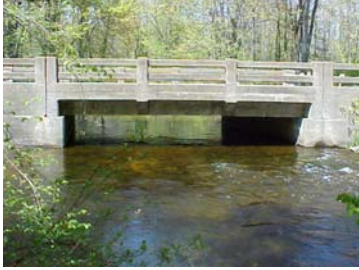
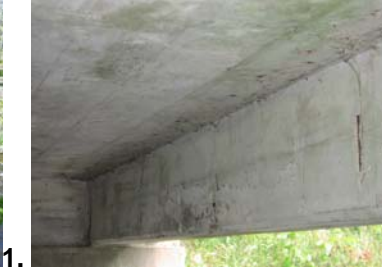
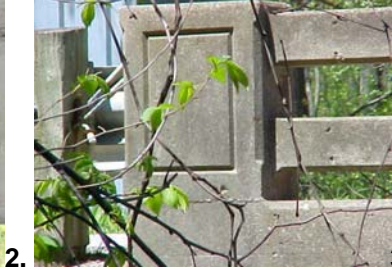
Asset/Bridge ID: 347-5007
Street and crossing: Carlisle Rd – Bronte Creek
Former Municipality(ies): Flamborough
UTM reference: E:581970
N:4804540
Date of survey: 22/05/02
Built heritage inventory file no: 601347
Heritage Evaluation Score and Grade: 38,D

Bridge type: beam
Bride Management System Subtype: T-beams
No. of spans: single
Construction period: 1901-1939
Date if known:
Builder/engineer if known:
Construction material(s) and Details: Concrete abutments support this concrete structure. A concrete balustrade stands on the deck. There are decorative cuts in balustrade. There are few signs of deterioration on the structure.
Integrity: There are no known alterations.
Historical associations: There are no known associations.
Notes: This structure was scored as having low heritage value. The structure's lack of associations inhibited its heritage value.
Documentation: There was no record found for this structure.

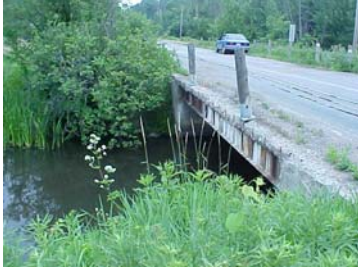
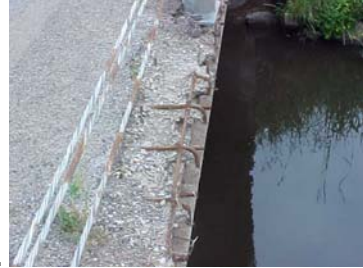
Asset/Bridge ID: 70-303
Street and crossing: Concession 10 E – Carlisle Creek
Former Municipality(ies): Flamborough
UTM reference: E:581560
N:4805890
Date of survey: 11/07/02
Built heritage inventory file no: 60170
Heritage Evaluation Score and Grade: 35,D

Construction material(s) and Details: Concrete abutments support this steel and concrete structure. There is great deterioration present. Much reinforcement is visible on the south side of the structure.

2) south face-exposed reinforcement

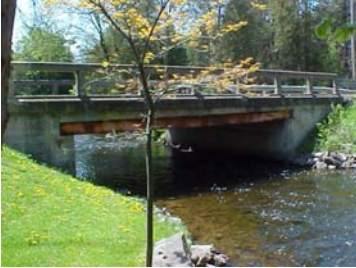
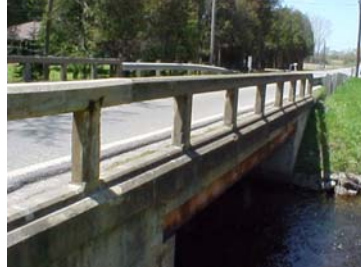
Asset/Bridge ID: 349-5006
Street and crossing: Centre Rd – Bronte Creek
Former Municipality(ies): Flamborough
UTM reference: E:581550
N:4805900
Date of survey: 22/05/02
Built heritage inventory file no: 601349
Heritage Evaluation Score and Grade: 38,D

Construction material(s) and Details: Concrete abutments support this steel and concrete structure. A concrete balustrade stands on the deck. There is much deterioration of the various components of the structure.

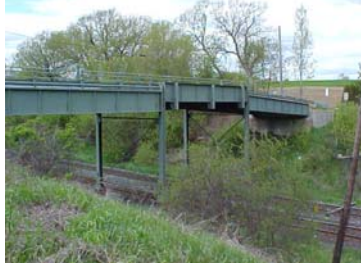
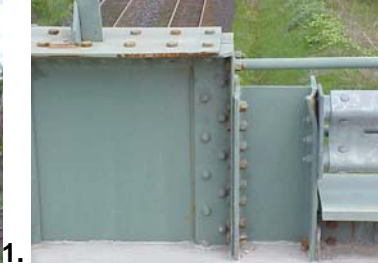
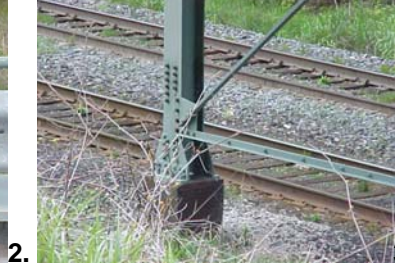
Construction material(s) and Details: Steel piers, which rest on concrete bases, support this steel multi-span structure. There are few signs of deterioration because the structure has been recently refurbished.

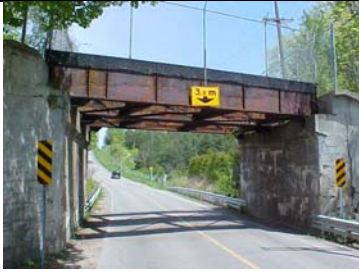
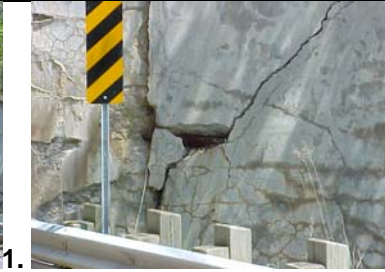
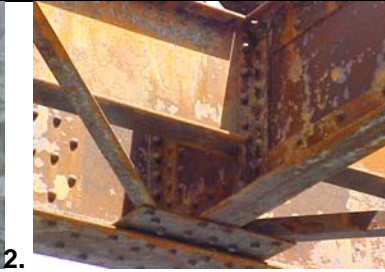
Asset/Bridge ID: 81-205
Street and crossing: Harvest Rd. –Rail line
Former Municipality(ies): Flamborough
UTM reference: E:582960
N:4792670
Date of survey: 27/05/02
Built heritage inventory file no: 60281
Heritage Evaluation Score and Grade: 40,C

Bridge type: beam
Bride Management System Subtype: I-beams
No. of spans: single
Construction period: 1901-1939
Date if known:
Builder/engineer if known:

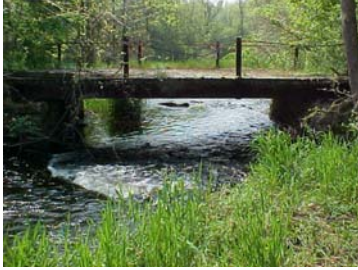
1.

Bridge type: beam
Bride Management System Subtype: I-beams
No. of spans: single
Construction period: 1901-1939
Date if known:
Builder/engineer if known:
Construction material(s) and Details: Stone abutments support this small steel and timber deck. There is much deterioration to the structure. The structure does not serve an active road.
Integrity: There are no known alterations.
Historical associations: There are no known associations.
Notes: This structure was scored as having low heritage value. The structure's lack of associations inhibited the structure's value.
Documentation: There was no record found for this structure.

Photos: 1) north face
2) underside
3) looking east

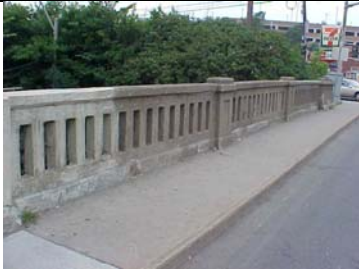
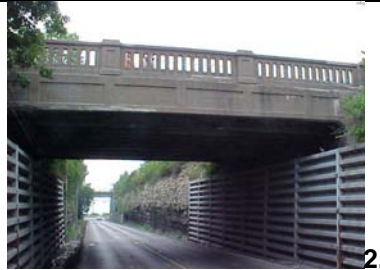
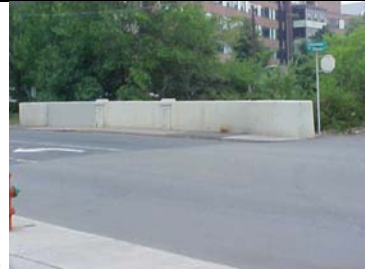
Construction material(s) and Details: This concrete structure shows signs of deterioration. The concrete balustrade has decorative cuts. The north face of the structure has been altered.

Photos: 1) South balustrade
2) South face
3) North balustrade

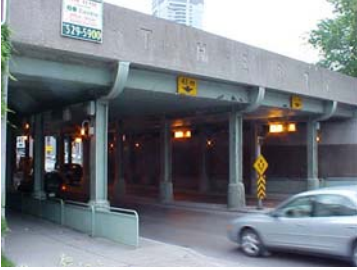
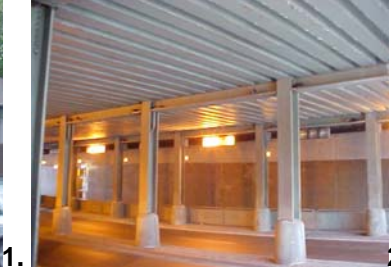
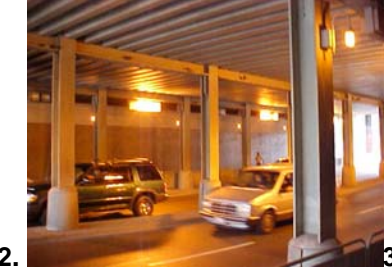
Construction material(s) and Details: Steel piers that rest on concrete bases support this multi-span steel structure. The steel components show some signs of deterioration. The T. H. & B. initials are imprinted in the deck.

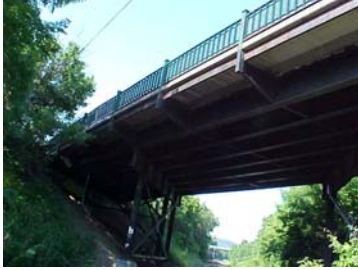
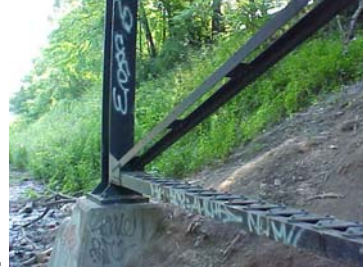
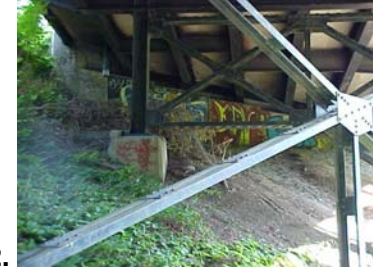
Construction material(s) and Details: Steel piers that rest on concrete bases support this multi-span steel structure. The concrete and steel components of this structure show few signs of deterioration.

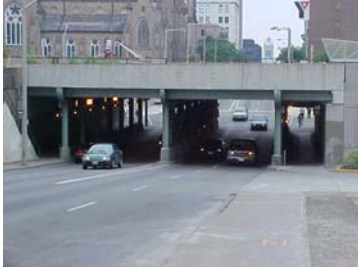
1.

Construction material(s) and Details: Steel piers that rest on concrete bases support this multi-span steel structure. The piers on this structure are of a different design than other similar structures along this rail line. The concrete components of this structure show some signs of deterioration. The T. H. & B. initials are imprinted in the deck.

Photos: 1) South face
2) Piers facing north
3) East abutment

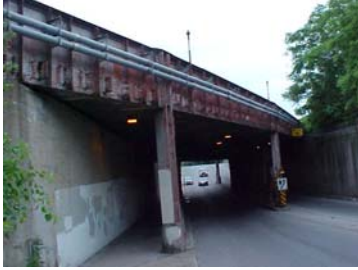
1.

Construction material(s) and Details: Steel piers that rest on concrete bases support this multi-span steel structure. The concrete and steel components of this structure show some signs of deterioration. Under the structure, the deck is possesses 2 clearance heights. There is a stairway with decorative features on the south side of the structure that allows for access to the street beside it.

Photos: 1) West face
2) Piers
3) Deck underside

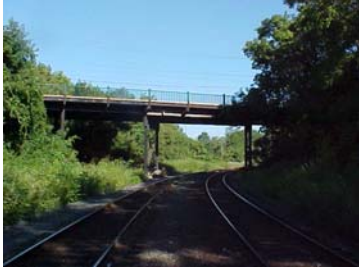
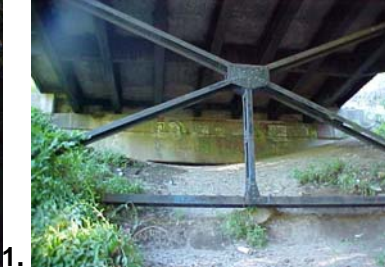
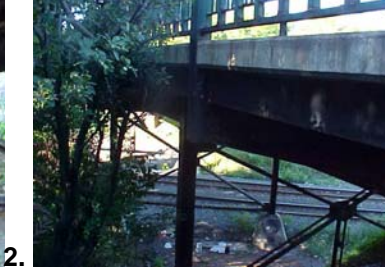
Construction material(s) and Details: Steel piers that rest on concrete bases support this multi-span steel structure. The concrete and steel components of this structure show few signs of deterioration.

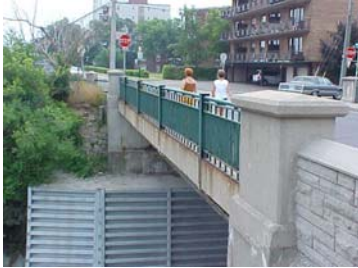
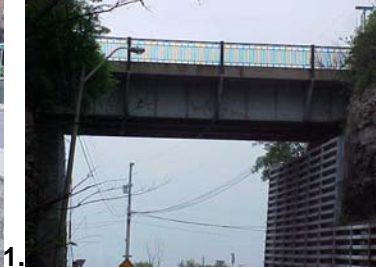
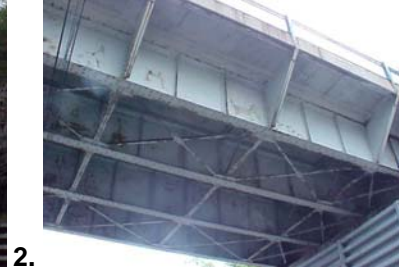
Asset/Bridge ID: 87-1542
Street and crossing: Mountain Park Ave.-Sherman Access
Former Municipality(ies): Hamilton
UTM reference: E:593940
N:4788180
Date of survey: 11/07/02
Built heritage inventory file no: 60187
Heritage Evaluation Score and Grade: 43,C

Bridge type: beam
Bride Management System Subtype: I-beams
No. of spans: single
Construction period: 1901-1939
Date if known:
Builder/engineer if known:
Construction material(s) and Details: This steel structure has a simple, decorative concrete and steel balustrade. There are some minor signs of deterioration.
Integrity: There is no evidence of alteration.
Historical associations: This structure is associated with road development surrounding the Sherman Access.
Notes: This structure scored respectably. The age and the integrity of this structure raised its heritage value.
Documentation: A written record of this structure was not found.

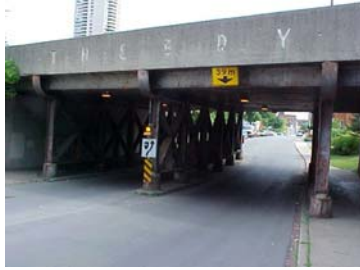
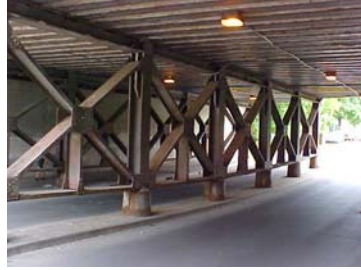
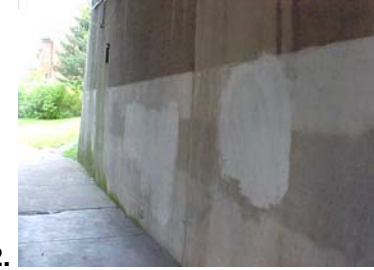
Construction material(s) and Details: This steel and concrete structure carries the railroad over Walnut Street. The steel piers rest atop concrete bases. It was constructed between 1930-1933. On the deck face of the structure the initials of the Toronto Hamilton and Buffalo Railway are imprinted. There is some deterioration to the deck and piers. Lights have been installed under the deck of the structure.

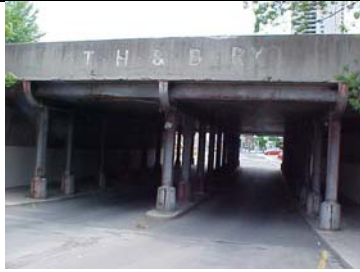
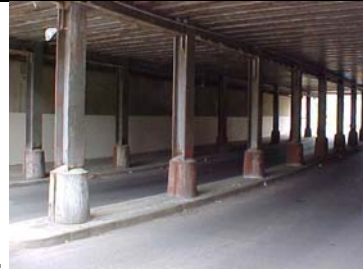
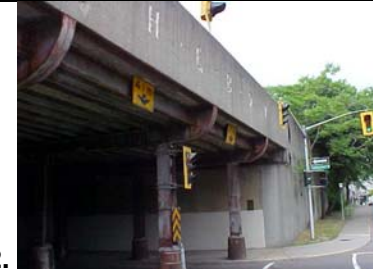
Construction material(s) and Details: This steel and concrete structure carries the railroad over Catherine street. The steel piers rest atop concrete bases. It was constructed between 1930-1933. On the deck face of the structure the initials of the Toronto Hamilton and Buffalo Railway are imprinted. There is some deterioration to the deck and piers. Lights have been installed under the deck of the structure.

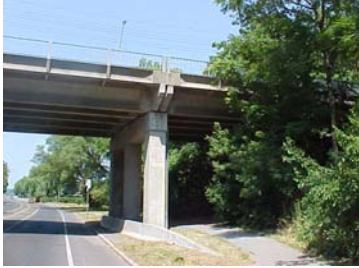
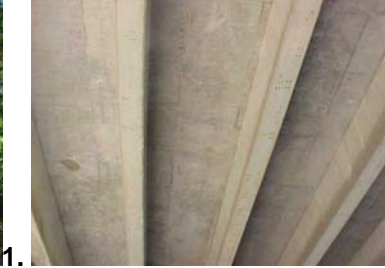
Bridge type: beam
Bride Management System Subtype: I-beams
No. of spans: 3
Construction period: 1940-1955
Date if known: 1955
Builder/engineer if known: C.C. Parker
Construction material(s) and Details: This pre-stressed concrete structure was the first of its kind in Hamilton. Concrete piers support this multi-span concrete structure. There is a simple metal balustrade on the deck.
Integrity: There is no evidence of alteration to this structure.
Historical associations: Lloyd D. Jackson, city mayor, won his long campaign for pre-stressed concrete with the construction of this structure. He had pushed for the implementation of the new technology on several structures constructed before this one, but never received the financial backing from city council.
Notes: This structure was scored as having moderate heritage value. It scored well because of its association and integrity.
Documentation: Newspaper articles were located which recorded Lloyd Jackson's comments on the new structure in 1955.

Photos: 1) West face
2) deck underside

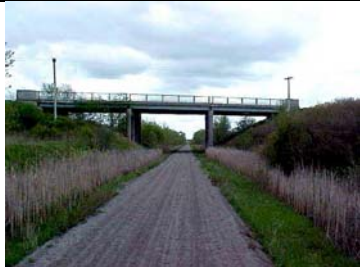
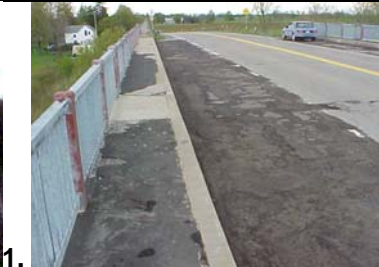
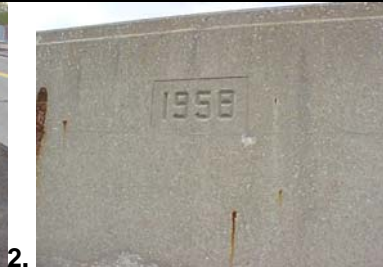
Construction material(s) and Details: Concrete abutments and piers support this steel and concrete structure. The construction date is imprinted in the balustrade. There are many signs of deterioration to various components of the structure.

3) date imprint in balustrade

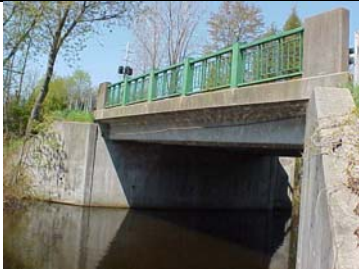
1.

Construction material(s) and Details: Concrete abutments support this concrete structure. There is little deterioration present at this site. The construction date is imprinted in the southwest balustrade.

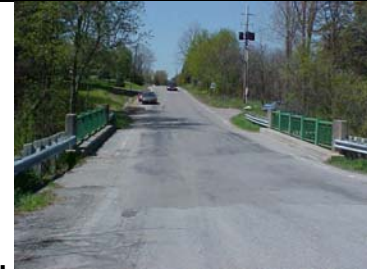
3.

3) looking north along deck

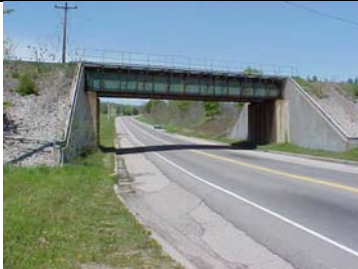
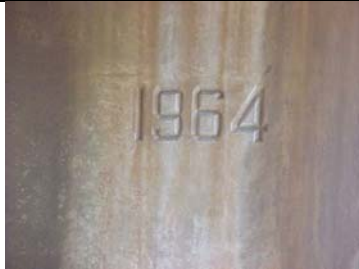
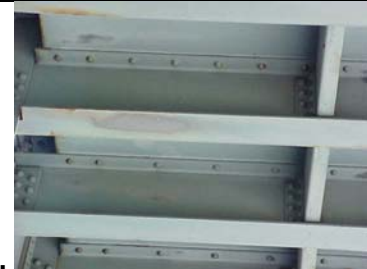
Construction material(s) and Details: Concrete abutments support this steel structure. The construction date is imprinted in the east abutment. There are some signs of deterioration to various components of the structure.

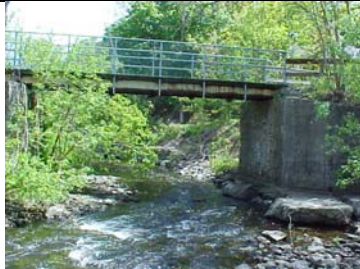
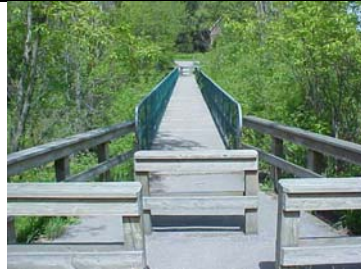
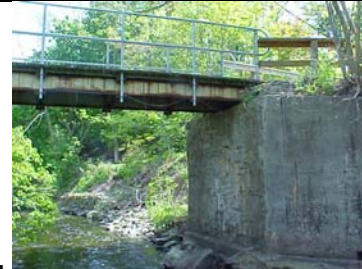
Construction material(s) and Details: Concrete abutments and piers support this steel structure. There are some signs of deterioration to various components of the structure. The abutments could possibly be the remnant of a former structure. The deck and abutments do not appear to be of the same design.

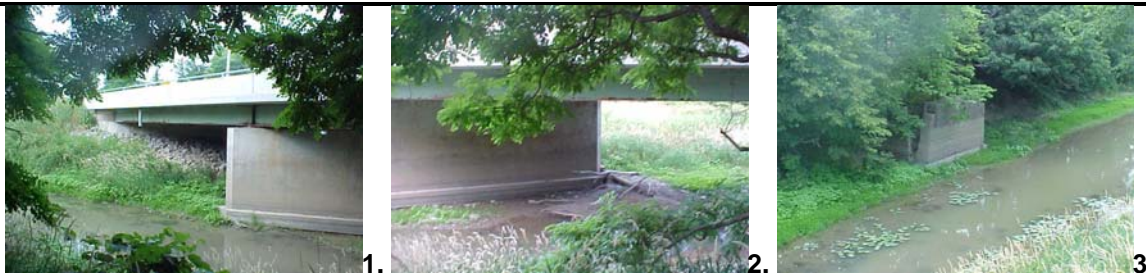
Asset/Bridge ID: 432-0008
Street and crossing: Sinclairville Rd. – Welland River
Former Municipality(ies): Glanbrook
UTM reference: E:600295
N:4767950
Date of survey: 17/07/02
Built heritage inventory file no: 601432
Heritage Evaluation Score and Grade: 44,C

Bridge type: beam

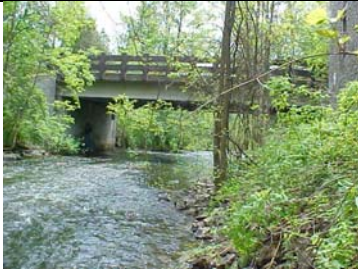
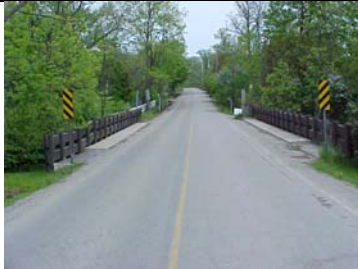
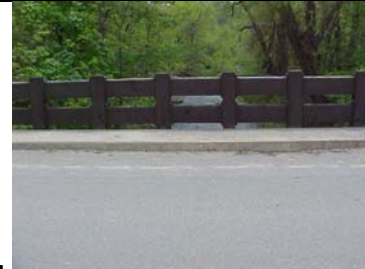
Construction material(s) and Details: Concrete abutments support this concrete structure. A wooden balustrade sits on the deck. There is little deterioration of this structure. The remnants of a steel truss, remain approximately 100m north of the structure.

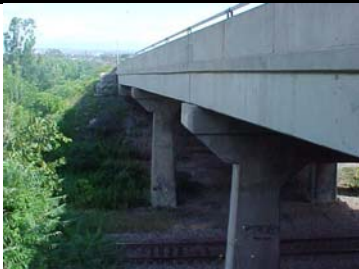
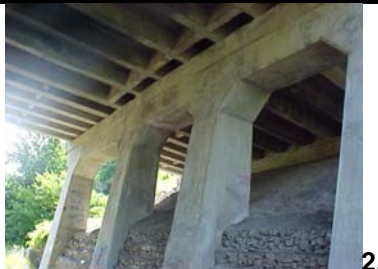
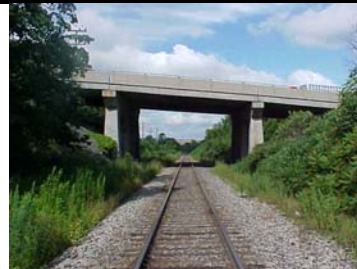
Construction material(s) and Details: Concrete piers support this multi-span concrete beam structure. There is little deterioration to the concrete components of this structure. There is a simple steel balustrade on the deck.

Photos: 1) Looking north along the structure
2) Piers, and deck underside
3) East face

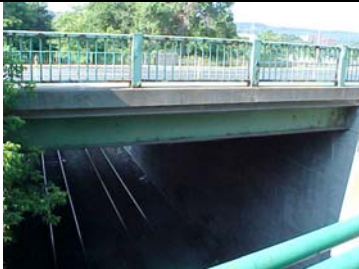
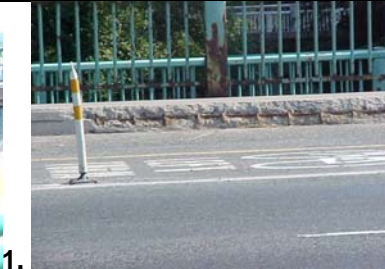
Construction material(s) and Details: This structure is composed of steel beams that support a concrete deck. There is obvious deterioration to both the simple steel balustrade and the concrete components to the deck. The reinforcement is visible in some spots. The steel beams in the superstructure show only minor signs of deterioration.

2) Deterioration on south side of deck

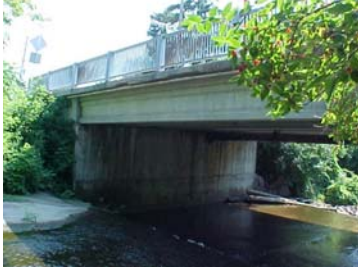
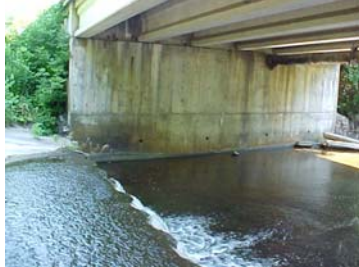
Construction material(s) and Details: This structure is composed of concrete beams that support a concrete deck. There is obvious deterioration to both the simple steel balustrade and the concrete components to the deck.

2) Underside of structure

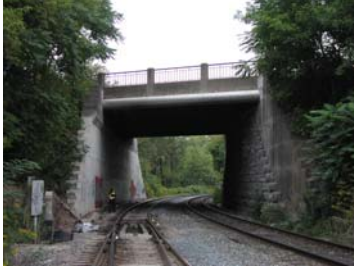
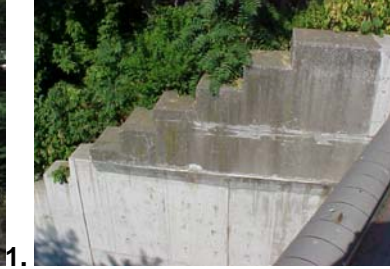
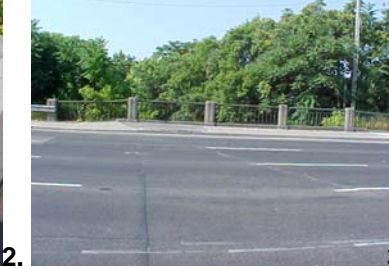
Asset/Bridge ID: 307-1088
Street and crossing: Main –Former T.H.&B. rail line
Former Municipality(ies): Hamilton
UTM reference: E: 590060
N: 4790300
Date of survey: 15/07/02
Built heritage inventory file no: 602307
Heritage Evaluation Score and Grade: 35,D

Bridge type: beam
Bride Management System Subtype: I-beams
No. of spans: single
Construction period: Post 1955
Date if known:
Builder/engineer if known:
Construction material(s) and Details: This steel and concrete structure shows signs of deterioration. The structure has stepped wing walls that extend from the abutment. There is also a steel balustrade on the deck.
Integrity: There are signs of some patchwork on the abutments.
Historical associations: There is little known about this structure besides its obvious association with the rail line and the rail development of the area.
Notes: This structure did not score well on the heritage evaluation. The structure's age and design inhibited its heritage value.
Documentation: A written record for the structure was not located.

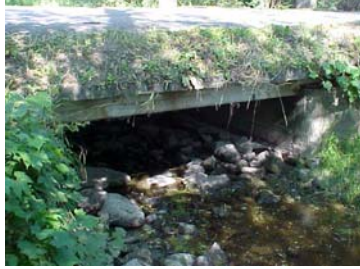
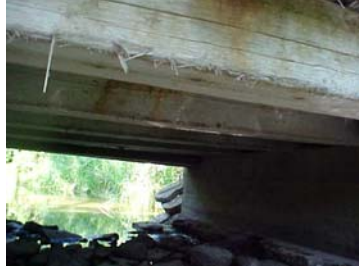
Construction material(s) and Details: This structure is similar to many of the other beam structures in the city, except this one is constructed with timbers. The structure shows some signs of deterioration.

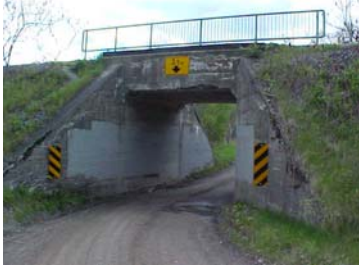
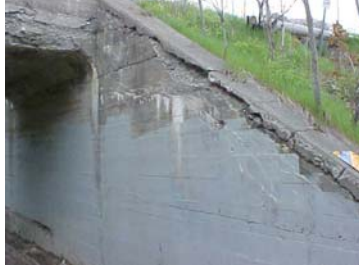
Construction material(s) and Details: This concrete structure shows signs of much deterioration. The former railway has been converted to a pedestrian trail.

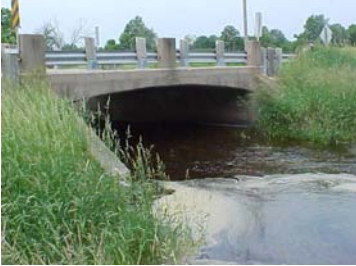
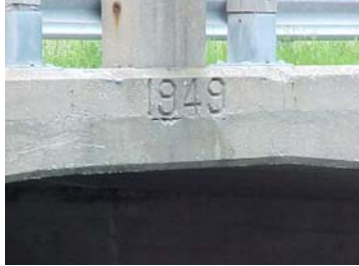
Bridge type: rigid frame
Bride Management System Subtype: rigid frame
No. of spans: single
Construction period: 1940-1955
Date if known: 1949
Builder/engineer if known:
Construction material(s) and Details: This concrete structure shows some deterioration The construction date is imprinted in the east deck face.
Integrity: The balustrade has been altered and in some sections removed. There is much unsympathetic patchwork on the structure. A metal guardrail has been added to the structure.
Historical associations: There are no known associations for this structure.
Notes: This structure did not score well on the heritage evaluation. Its design, integrity, and lack of historical associations inhibited the structure's heritage value.
Documentation: A written record for the structure was not located.

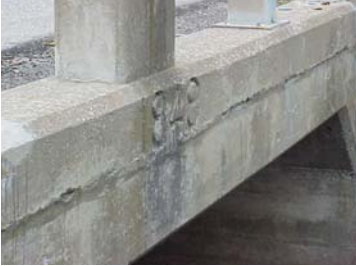
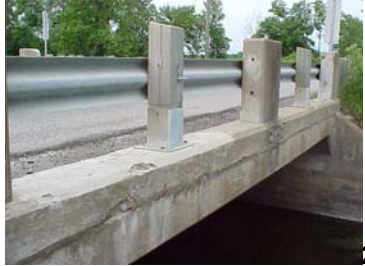
Asset/Bridge ID: 341-5003
Street and crossing: Westover – unknown creek
Former Municipality(ies): Flamborough
UTM reference: E: 575460
N: 4793090
Date of survey: 24/06/02
Built heritage inventory file no: 601341
Heritage Evaluation Score and Grade: 19,D

Bridge type: rigid frame
Bride Management System Subtype: rigid frame
No. of spans: single
Construction period: 1940-1955
Date if known: 1949
Builder/engineer if known:
Construction material(s) and Details: This concrete structure shows some signs of deterioration. The construction date is imprinted in the east face of the structure.
Integrity: There is some minor patchwork on the concrete sections of this structure. The balustrade has been altered. Some sections of the balustrade have been removed.
Historical associations: There are no known associations for this structure.
Notes: This structure did not score well on the heritage evaluation. Its design, integrity, and lack of historical associations inhibited the structure's heritage value.
Documentation: A written record for the structure was not located.

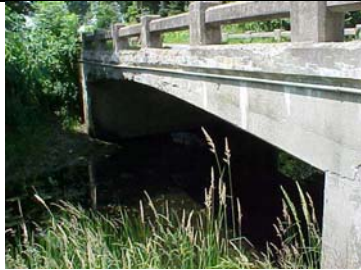
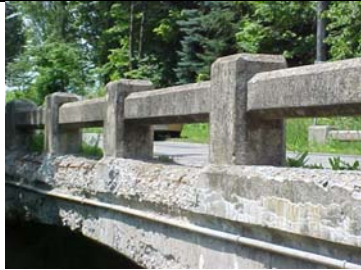
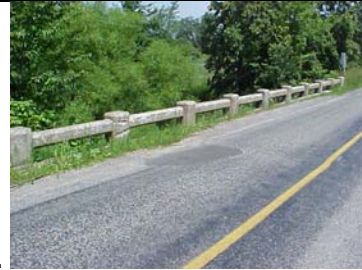
Construction material(s) and Details: This concrete structure shows some deterioration. The reinforcement is visible on some parts of the structure. A concrete balustrade stands on the deck.

3) West balustrade

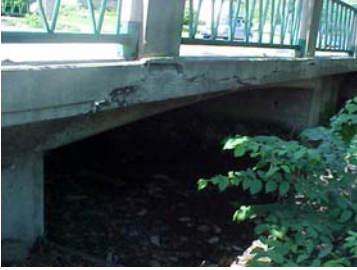
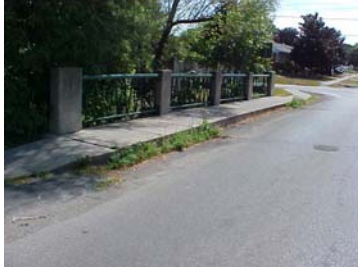
Construction material(s) and Details: This concrete structure has a concrete and steel balustrade. There is some deterioration to most components of the structure. There are decorative cuts in the concrete components of the balustrade.

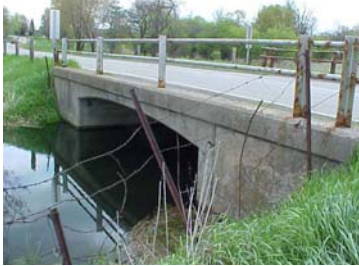
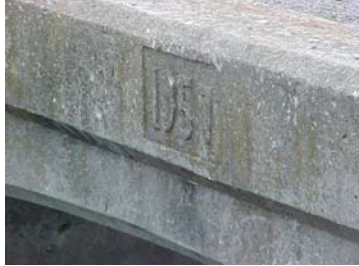
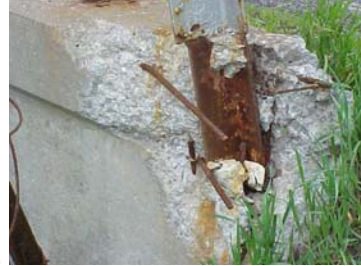
Asset/Bridge ID: 414-0016
Street and crossing: Miles Rd. - Twenty Mile Creek
Former Municipality(ies): Glanbrook
UTM reference: E: 591810
N: 4780370
Date of survey: 14/05/02
Built heritage inventory file no: 601414
Heritage Evaluation Score and Grade: 34,D

Construction material(s) and Details: This concrete structure shows some deterioration. The reinforcement is visible on some parts of the structure. A steel balustrade stands on the deck.

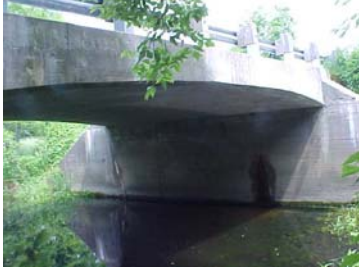
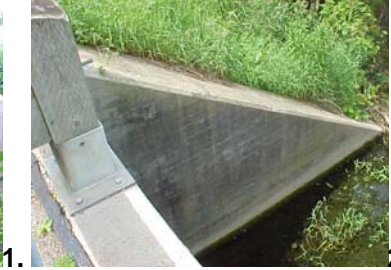
Built heritage inventory file no: 601357

Construction material(s) and Details: This structure is composed of concrete. There is no obvious deterioration to this structure.

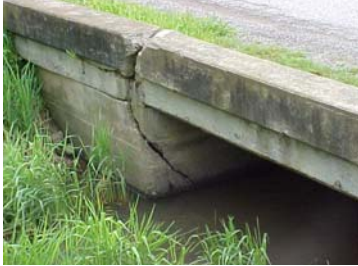
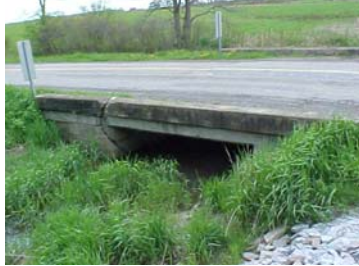
Asset/Bridge ID: 415-0017
Street and crossing: Trinity Rd. – Twenty Mile Creek
Former Municipality(ies): Glanbrook
UTM reference: E: N/A
N: N/A
Date of survey: 17/05/02
Built heritage inventory file no: 601415
Heritage Evaluation Score and Grade: 31,D

Construction material(s) and Details: This concrete structure shows some deterioration. There are large cracks in the abutments.

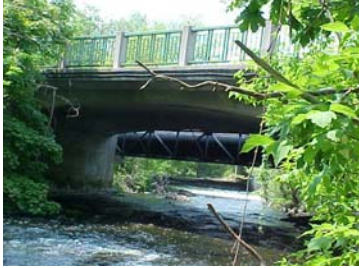
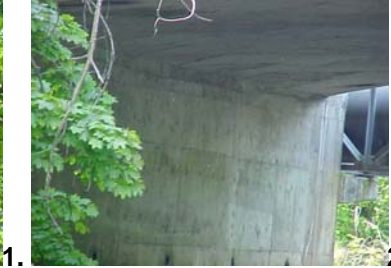
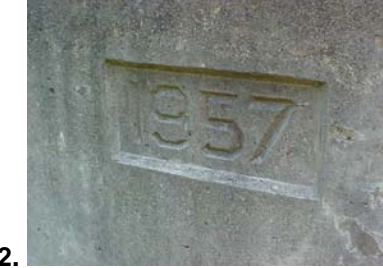
Built heritage inventory file no: 601296

Construction material(s) and Details: This concrete structure shows little sign of deterioration. There is a simple, steel balustrade on the deck. The construction date is imprinted on the north balustrade.
