Heritage Structure Assessment

This assessment is the resulting product of a heritage study on bridge structures in the City of Hamilton. The study and the assessment were conducted from May to August 2002. The aim was to establish a heritage record for all bridge structures over the age of 35 years. The assessment is a required component of the Class Environmental Assessment that will be conducted on the city's bridge structures later in 2002. The Environmental Assessment Act mandates the heritage data will be considered in any final decisions that may impact the nature of a structure.

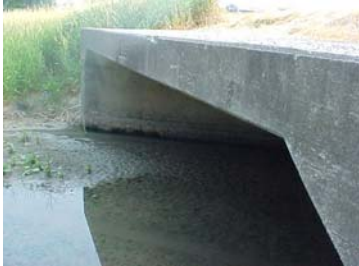
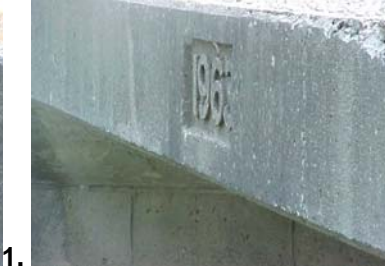
Asset/Bridge ID: 435-0011
Street and crossing: Berry Rd.- Little Wolf Creek
Former Municipality(ies): Glanbrook
UTM reference: E: 601860
N: 4769740
Date of survey: 17/07/02
Built heritage inventory file no: 601435
Heritage Evaluation Score and Grade: 27,D

Bridge type: rigid frame
Bride Management System Subtype: rigid frame
No. of spans: single
Construction period: Post 1955
Date if known: 1963
Builder/engineer if known:
Construction material(s) and Details: This concrete structure shows little deterioration. The construction date is imprinted in the west deck face.
Integrity: There is no evidence of alteration.
Historical associations: There are no known associations for this structure.
Notes: This structure did not score well on the heritage evaluation. Its design and lack of historical associations inhibited the structure's heritage value.
Documentation: A written record for the structure was not located.

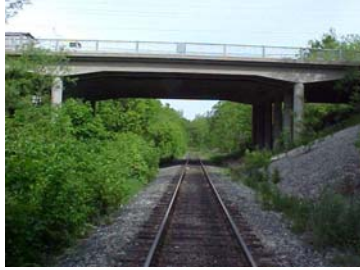
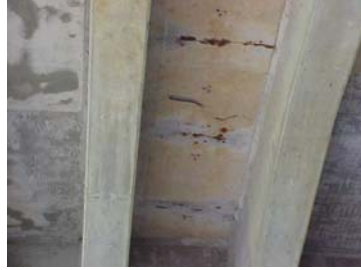
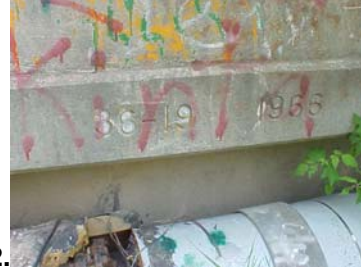
Built heritage inventory file no: 602450

Construction material(s) and Details: Concrete piers support this continuous concrete span. This span crosses both the rail line and a small tributary of Grindstone Creek. There is some deterioration to the various concrete components. The construction date is imprinted in the balustrade.

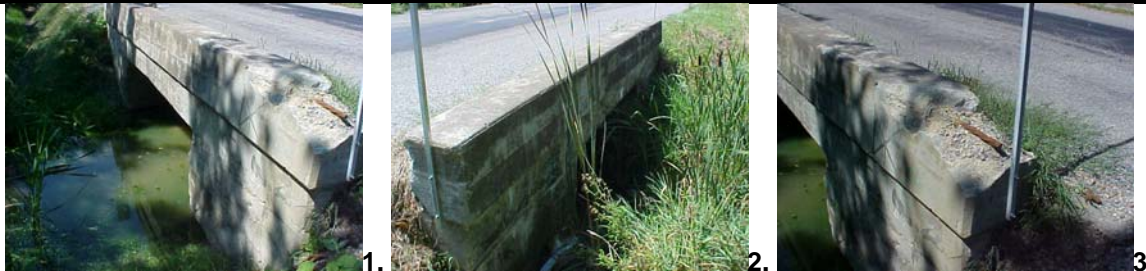
Built heritage inventory file no: 601419

Construction material(s) and Details: This concrete structure shows some deterioration. The reinforcement is visible on some parts of the structure.

Photos: 1) South face
2) North face
3) Exposed reinforcement

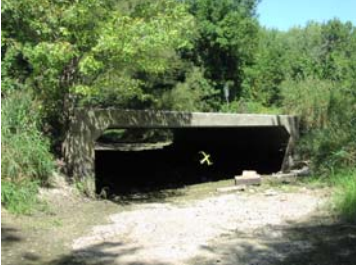
Asset/Bridge ID: 50-003104
Street and crossing: 3rd Rd. East – Stoney Creek
Former Municipality(ies): Stoney Creek
UTM reference: E: 602950
N: 4783500
Date of survey: 26/06/02
Built heritage inventory file no: 60150
Heritage Evaluation Score and Grade: 27,C

Bridge type: rigid frame
Bride Management System Subtype: rigid frame
No. of spans: 1
Construction period: Post 1955
Date if known:
Builder/engineer if known:
Construction material(s) and Details: This concrete structure shows some signs of deterioration.
Integrity: There is no evidence of alteration.
Historical associations: There are no known associations for this structure.
Notes: This structure did not score well on the heritage evaluation. The design and lack of association inhibited the heritage value of the structure.
Documentation: A written record for the structure was not located.

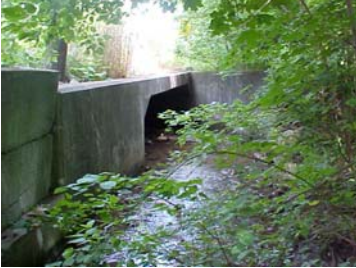
Asset/Bridge ID: 113-0020
Street and crossing: Sulphur Springs- Spring Creek
Former Municipality(ies): Ancaster
UTM reference: E: 580980
N: 4788700
Date of survey: 21/05/02
Built heritage inventory file no: 601113
Heritage Evaluation Score and Grade: 27,D

Bridge type: rigid frame
Bride Management System Subtype: rigid frame
No. of spans: single
Construction period: Post 1955
Date if known: Builder/engineer if known:
Construction material(s) and Details: This concrete structure shows some deterioration.
Integrity: There is no evidence of alteration.
Historical associations: There are no known associations for this structure.
Notes: This structure did not score well on the heritage evaluation. Its design and lack of associations inhibited the heritage value of the structure.
Documentation: A written record for the structure was not located.

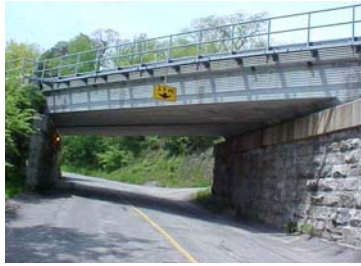
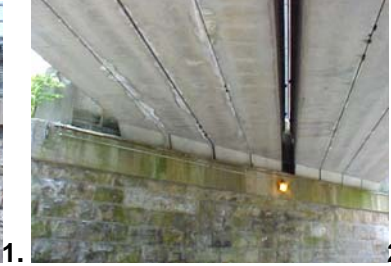
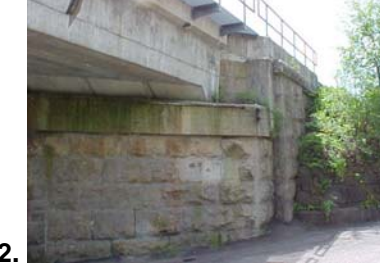
Built heritage inventory file no: 602456

Construction material(s) and Details: This structure is composed of concrete and steel. It is suspected that the abutments are part of the original structure. However, the steel and concrete deck is not typical of the suspected construction period. Furthermore the steel and concrete components do not reflect the deterioration that would be present in a 100 year old structure. The deck accommodates a two track railway.

Integrity: It is suspected that the deck has been heavily refurbished or replaced. Since this could not be confirmed it was scored as being sympathetically modified. There is some patchwork on the abutments of the structure.

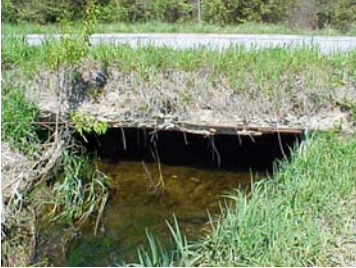
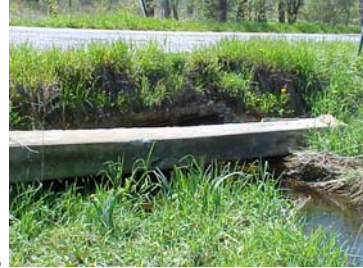
Asset/Bridge ID: 63-316
Street and crossing: Puslinch Townline – Bronte Creek
Former Municipality(ies): Flamborough
UTM reference: E:574200
N:4809590
Date of survey: 23/05/02
Built heritage inventory file no: 60163
Heritage Evaluation Score and Grade: 38,D

Bridge type: slab
Bride Management System Subtype: solid slab
No. of spans: single
Construction period: 1901-1939
Date if known: 1925
Builder/engineer if known:
Construction material(s) and Details: This structure is composed of concrete. There is significant deterioration to the structure. The reinforcement is visible in many areas of the structure. A large concrete beam has become totally detached from the structure. There is a date imprint on the beam.
Integrity: There is no evidence of deliberate alteration to the structure. However, the structure has deteriorated so much that its original integrity has been jeopardized.
Historical associations: There are no known associations for this structure.
Notes: This structure did not score well. The structure's design, integrity and lack of associations inhibited its heritage value.
Documentation: No written record for this structure was located.

Photos: 1) south face
2) north face

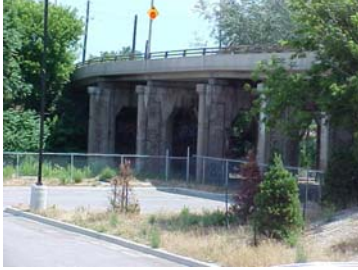
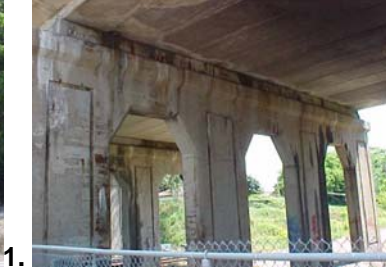
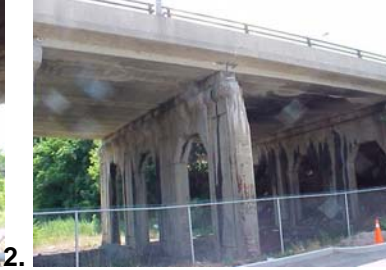
Asset/Bridge ID: 181-1071
Street and crossing: John-Former GW.R. line
Former Municipality(ies): Hamilton
UTM reference: E:592340
N:4790950
Date of survey: 11/07/02
Built heritage inventory file no: 602181
Heritage Evaluation Score and Grade: 33,D

Construction material(s) and Details: Concrete piers support this multi-span concrete structure. The concrete components show signs of deterioration. The construction date is imprinted in the north abutment. The deck is obviously a replacement of the original deck. The large concrete piers have decorative cuts in them.

Integrity: The current slab deck has replaced what was suspected to have been steel beams deck, which was probably similar to other structures along the railway. A record of the refurbishing was not located.

Photos: 1) West face
2) Piers- facing north
3) Piers-facing south

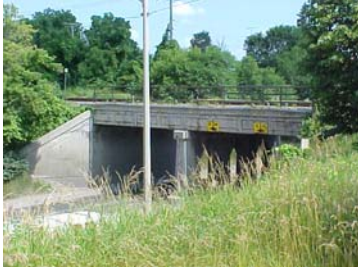
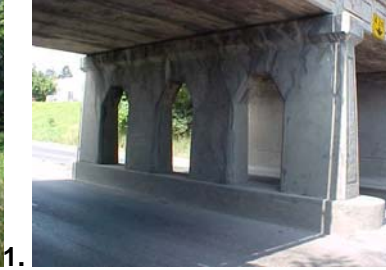
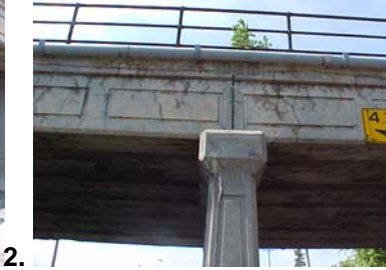
Asset/Bridge ID: 163-1067
Street and crossing: Centennial Parkway –C.N. Rail
Former Municipality(ies): Hamilton
UTM reference: E:600800
N:4788395
Date of survey: 4/7/02
Built heritage inventory file no: 602163
Heritage Evaluation Score and Grade: 48,C

Construction material(s) and Details: A concrete pier supports this concrete slab. There are decorative cuts in the deck, abutments, and the piers. The date is imprinted both in the abutments and on the deck. There is a simple steel balustrade on the deck. There is some deterioration to the concrete components of this structure.

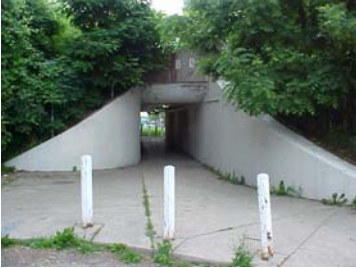
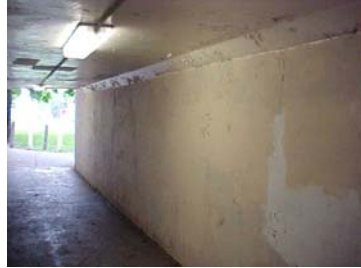
Asset/Bridge ID: 167-1046
Street and crossing: Ferguson and former T.H. & B.
Former Municipality(ies): Hamilton
UTM reference: E:N/A
N:N/A
Date of survey: 24/06/02
Built heritage inventory file no: 602167
Heritage Evaluation Score and Grade: 38,D

Bridge type: slab
Bride Management System Subtype: box, closed footing
No. of spans: single
Construction period: 1901-1939
Date if known:
Builder/engineer if known:
Construction material(s) and Details: This structure is composed of concrete. There is some obvious deterioration to this structure. The Toronto, Hamilton and Buffalo Railway initials are imprinted in the deck. This structure serves as a pedestrian walkway under the rail line.
Integrity: There is some patchwork to the abutments of the structure.
Historical associations: This structure was constructed as part of a grade separation that was undertaken by the T.H.&B. in the early 1930's.
Notes: This structure did no score well. Although it did score some points with regard to its historical and aesthetic characteristics.
Documentation: No written record for this structure was located.

Photos: 1) South face
2) Under the deck-facing north.

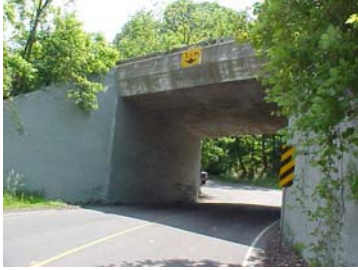
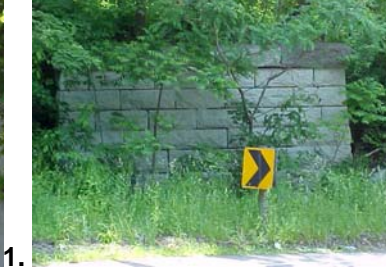
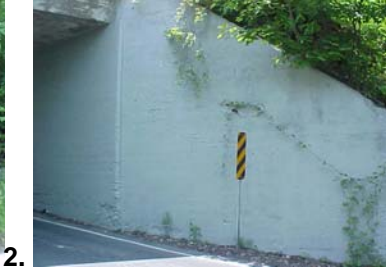
Asset/Bridge ID: 165-4005
Street and crossing: New Mountain Road –Former T.H.B. Rail
Former Municipality(ies): Stoney Creek
UTM reference: E:601650
N:4785200
Date of survey: 11/06/02
Built heritage inventory file no: 602165
Heritage Evaluation Score and Grade: 43,C

Construction material(s) and Details: This concrete structure shows some signs of deterioration. The reinforcement is barely visible on the underside of the deck. Southwest of the structure are the remnants of what could have been former abutments.

Photos: 1) North face
2) Suspected former abutment
3) Refurbished wing wall

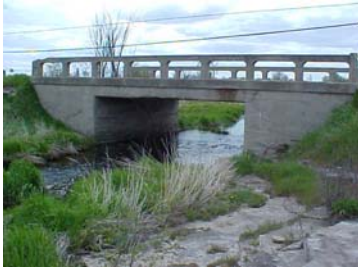
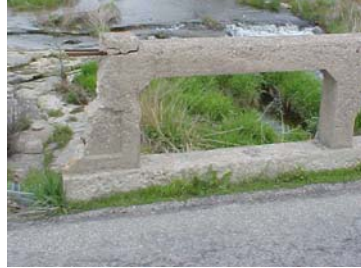
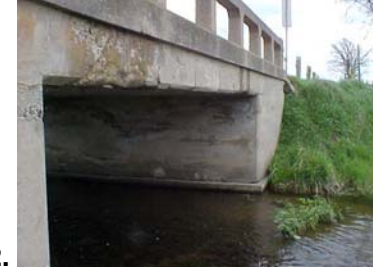
Asset/Bridge ID: 25-107
Street and crossing: Lynden Rd. – Barlow creek
Former Municipality(ies): Flamborough
UTM reference: E: 568350
N: 4791280
Date of survey: 21/05/02
Built heritage inventory file no: 60125
Heritage Evaluation Score and Grade: 38,D

Construction material(s) and Details: This structure is composed of concrete. There is some deterioration to the structure. The concrete balustrade has some great deterioration. The reinforcement is visible in some sections of the structure.

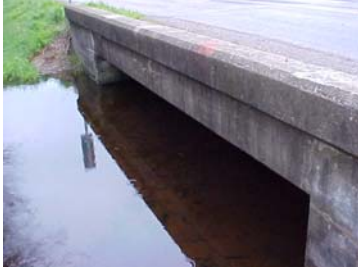
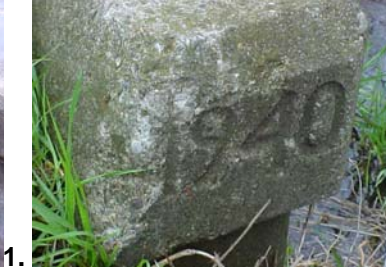
Asset/Bridge ID: 15-121
Street and crossing: Concession 4 W –Spencer Creek
Former Municipality(ies): Flamborough
UTM reference: E: 576205
N: 4794690
Date of survey: 13/05/02
Built heritage inventory file no: 60115
Heritage Evaluation Score and Grade: 34,D

Bridge type: slab
Bride Management System Subtype: solid slab
No. of spans: single
Construction period: 1940-1955
Date if known: 1940
Builder/engineer if known:
Construction material(s) and Details: This structure is composed of concrete. There is little deterioration of the structure. The construction date has been imprinted on the southwest portion of the deck.
Integrity: There are no signs of alteration.
Historical associations: There are no known associations for this structure.
Notes: This structure did not score well. The structure's design, and lack of associations inhibited its heritage value.
Documentation: No written record for this structure was located.

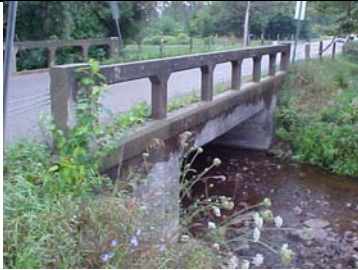
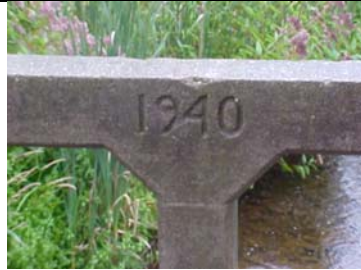
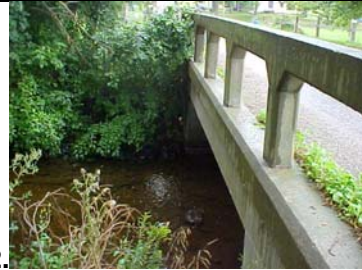
Asset/Bridge ID: 13-115
Street and crossing: Concession 6 W – Moffat's Creek
Former Municipality(ies): Flamborough
UTM reference: E:575800
N:4798650
Date of survey: 19/08/02
Built heritage inventory file no: 60113
Heritage Evaluation Score and Grade: 34,D

Construction material(s) and Details: This structure is composed of concrete. There is some obvious deterioration to this structure. The construction date is imprinted in the north balustrade.

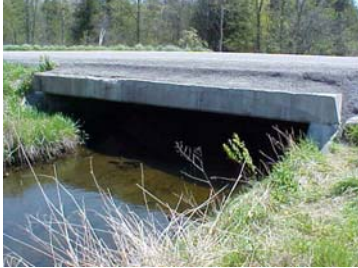
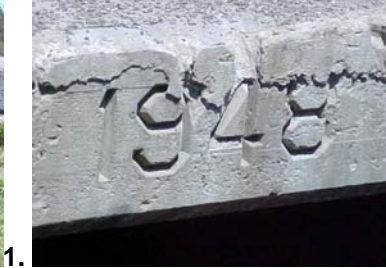
Asset/Bridge ID: 64-307
Street and crossing: Concession 14 E – Bronte Creek
Former Municipality(ies): Flamborough
UTM reference: E:579310
N:4809120
Date of survey: 15/08/02
Built heritage inventory file no: 60164
Heritage Evaluation Score and Grade: 34,D

Bridge type: slab
Bride Management System Subtype: solid slab
No. of spans: single
Construction period: 1940-1955
Date if known: 1948
Builder/engineer if known:
Construction material(s) and Details: This structure is composed of concrete. There is some minor deterioration to this structure. The construction date is imprinted in the south deck face.
Integrity: There is no evidence of alteration.
Historical associations: There are no known associations for this structure.
Notes: This structure did not score well. The structure's design and lack of associations inhibited its heritage value.
Documentation: No written record for this structure was located.

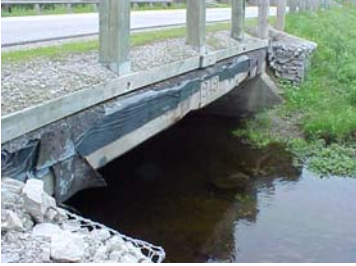
Asset/Bridge ID: 348-5004
Street and crossing: Campbellville Rd. – Bronte Creek
Former Municipality(ies): Flamborough
UTM reference: E:575860
N:4808030
Date of survey: 06/06/02
Built heritage inventory file no: 601348
Heritage Evaluation Score and Grade: 34,D

Bridge type: slab
Bride Management System Subtype: solid slab
No. of spans: single
Construction period: 1940-1955
Date if known: 1949
Builder/engineer if known:
Construction material(s) and Details: This structure is composed of concrete. There is some minor deterioration to this structure. The construction date is imprinted in the east deck face.
Integrity: There is no evidence of alteration. Black tarp covers sections of structure.
Historical associations: There are no known associations for this structure.
Notes: This structure did not score well. The structure's design and lack of associations inhibited its heritage value.
Documentation: No written record for this structure was located.

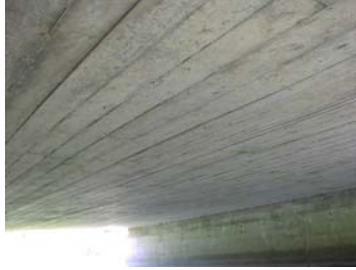
2.

Photos: 1) east face
2) underside of deck

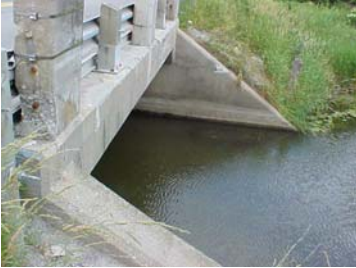
1.

Construction material(s) and Details: This structure is composed of concrete. There is some obvious deterioration to this structure. There is a concrete and steel balustrade on the deck. The construction date is imprinted in the west deck face.

Photos: 1) South face
2) North face-close
3) North balustrade

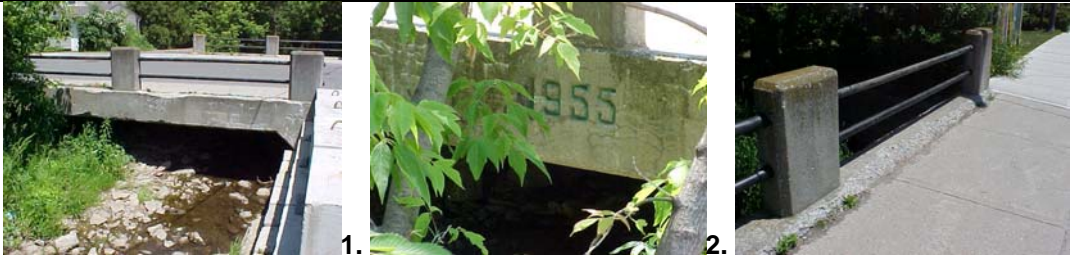
Asset/Bridge ID: 48/001114
Street and crossing: Jones Rd. –Stoney Creek
Former Municipality(ies): Stoney Creek
UTM reference: E:601150
N:4785680
Date of survey: 6/18/02
Built heritage inventory file no: 60148
Heritage Evaluation Score and Grade: 34,D

Bridge type: Slab
Bride Management System Subtype: Solid slab
No. of spans: single
Construction period: 1940-55
Date if known: 1955
Builder/engineer if known:
Construction material(s) and Details: Structure is composed of concrete and possess a simple decorative balustrade. The construction date is stamped into the north face.
Integrity: There is no evidence of alteration.
Historical associations: There are no known historical associations.
Notes: Structure scored well on integrity. However, overall it scored low due to its lack of historical associations and uniqueness.
Documentation: A written record for the structure was not located.

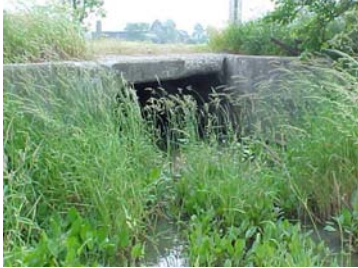
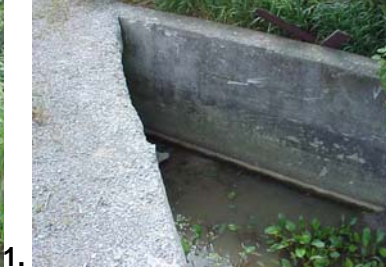
Bridge type: slab
Bride Management System Subtype: solid slab
No. of spans: 1
Construction period: 1940-1955
Date if known:
Builder/engineer if known:
Construction material(s) and Details: This simple concrete box has one wing wall that extends north on the west face.
Integrity: There is no evidence of alteration.
Historical associations: There are no known historical associations.
Notes: This structure scored low on the heritage evaluation. It did not score well because its lack of historical associations. It also scored low for being a relatively young concrete structure.
Documentation: A written record for the structure was not located.

Photos: 1) West face
2) East face-from above

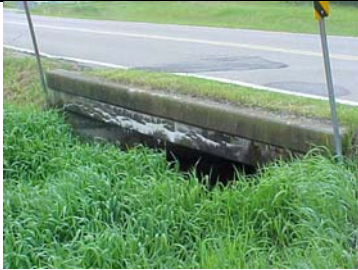
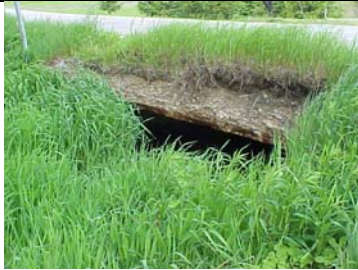
Construction material(s) and Details: This simple concrete box has much deterioration present. Reinforcement is visible, most notably on the south face.

2) South face

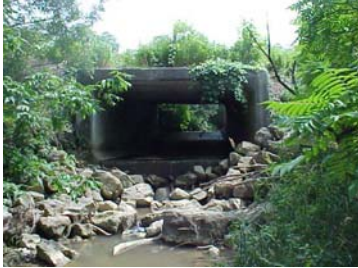
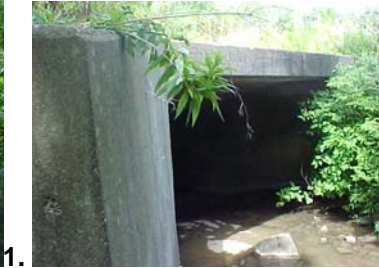
Bridge type: slab
Bride Management System Subtype: box, closed footing
No. of spans: 1
Construction period: 1940-1955
Date if known:
Builder/engineer if known:
Construction material(s) and Details: This simple concrete box has a sloped base, which accelerated the creek slightly. The east face has wing walls that extend from the structure, they are not present on the opposite face.
Integrity: There is no evidence of alteration.
Historical associations: There are no known historical associations.
Notes: This structure scored low on the heritage evaluation. It did not score well because its lack of historical associations. It also scored low for being a relatively young concrete structure. It scored well on integrity—having no known material modifications.
Documentation: A written record for the structure was not located.

Photos: 1) West face
2) East face

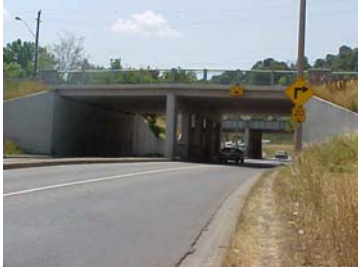
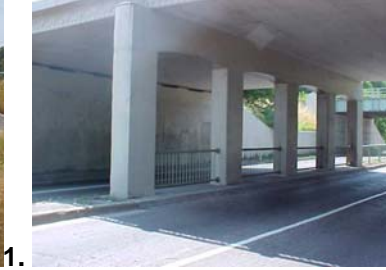
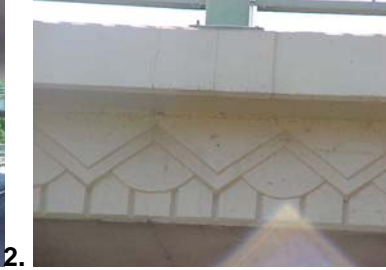
Bridge type: slab
Bride Management System Subtype: Slab-Circular voids
No. of spans: Continuous
Construction period: 1940-1955
Date if known:
Builder/engineer if known:

Construction material(s) and Details: This structure is composed of concrete and has a simple, decorative, steel balustrade. A concrete pier supports the deck. The deck that crosses the roadway is a continuous span. There are decorative cuts in the concrete deck.

Photos: 1) North face
2) Pier
3) Decorative cuts in deck

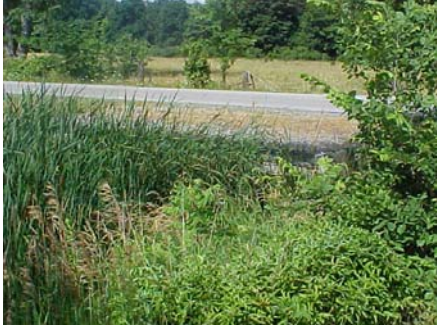
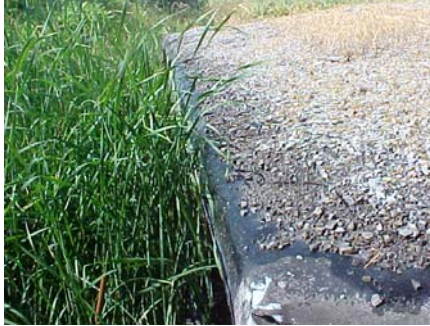
Construction material(s) and Details: This structure is composed of concrete. There is some obvious deterioration to this structure.

2) West side of deck, looking down.

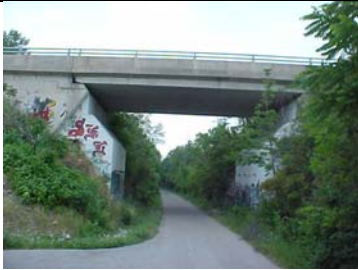
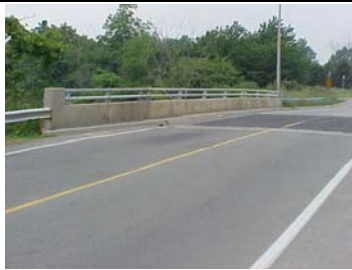
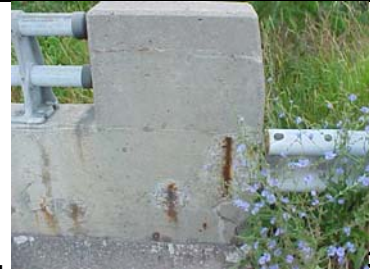
Construction material(s) and Details: This structure is composed of concrete and has a simple steel balustrade. In some places the reinforcement is visible, but there are no other major signs of deterioration.

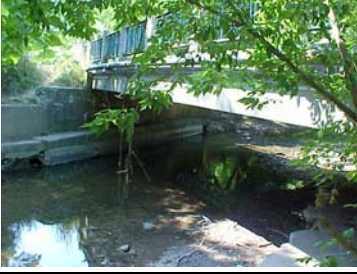
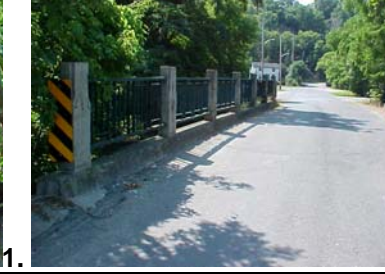
Asset/Bridge ID: 95-00104
Street and crossing: Thorpe Street- Spencer Creek
Former Municipality(ies): Dundas
UTM reference: E:585560
N:4790660
Date of survey: 15/07/02
Built heritage inventory file no: 60195
Heritage Evaluation Score and Grade: 34,D

Bridge type: slab
Bride Management System Subtype: Rectangular
No. of spans: single
Construction period: 1940-1955
Date if known:
Builder/engineer if known:
Construction material(s) and Details: This structure is composed of concrete and has a simple, decorative, steel balustrade. There are obvious signs of deterioration on the abutments.
Integrity: There is no evidence of alteration.
Historical associations: There are no known historical associations for this structure.
Notes: This structure did no score well. It did not score points relative to its design and historic characteristics.
Documentation: A written record for the structure was not located.

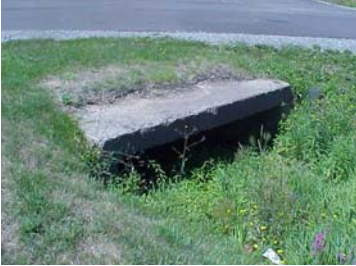
Asset/Bridge ID: 46-002221
Street and crossing: Willow Street-Stoney Creek
Former Municipality(ies): Stoney Creek
UTM reference: E:607305
N:4785595
Date of survey: 20/08/02
Built heritage inventory file no: 60146
Heritage Evaluation Score and Grade: 31,D

Bridge type: slab
Bride Management System Subtype: solid slab
No. of spans: single
Construction period: 1940-1955
Date if known:
Builder/engineer if known:
Construction material(s) and Details: This structure is composed of concrete. There is some obvious deterioration to this structure.
Integrity: There is no evidence of alteration.
Historical associations: There are no known associations for this structure.
Notes: This structure did no score well. It did not score points relative to its design, historic, and aesthetics characteristics.
Documentation: No written record for this structure was located.

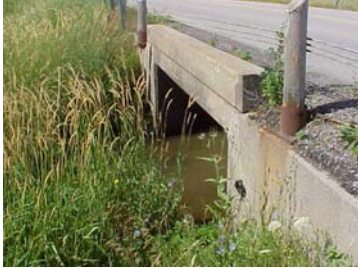
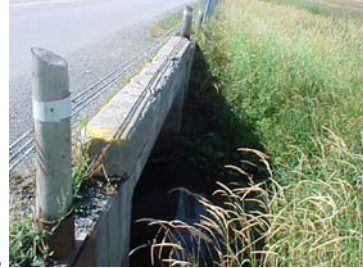
Construction material(s) and Details: This structure is composed of concrete. There is some obvious deterioration to this structure.

2) East face

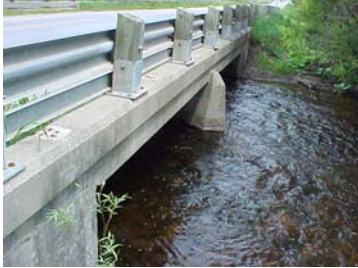
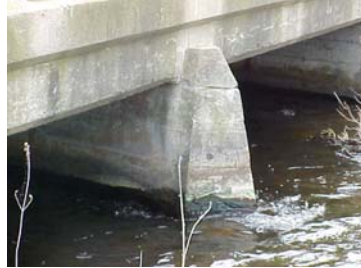
Construction material(s) and Details: This concrete slab shows no signs of deterioration. A concrete pier supports the continuous deck span.

2) Pier

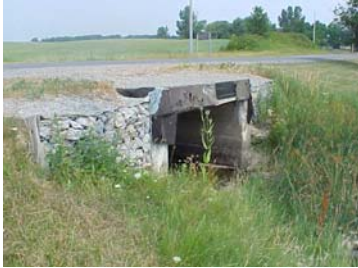
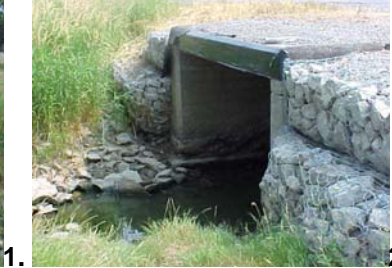
Construction material(s) and Details: This structure is composed of concrete. There is some obvious deterioration to this structure.

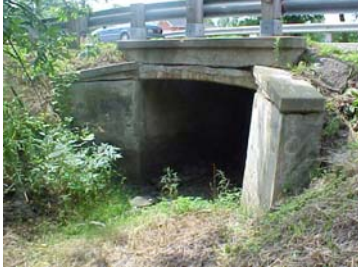
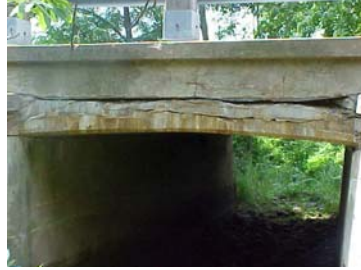
Construction material(s) and Details: This structure is composed of concrete. There is some obvious deterioration to this structure.

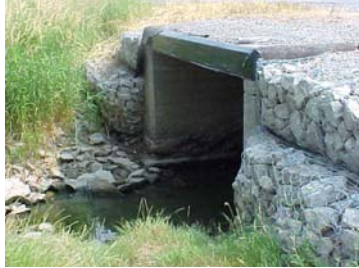
2.

Construction material(s) and Details: This structure is composed of concrete. There is some obvious deterioration to this structure.

2) west face

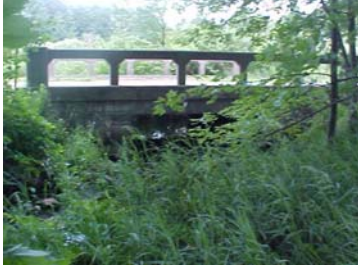
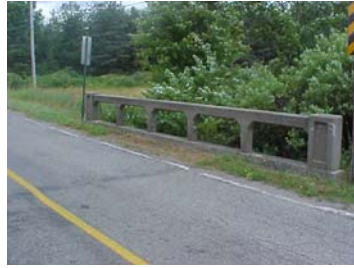
Construction material(s) and Details: This structure is composed of concrete and has a concrete balustrade. There is some minor deterioration to this structure.

2) west balustrade

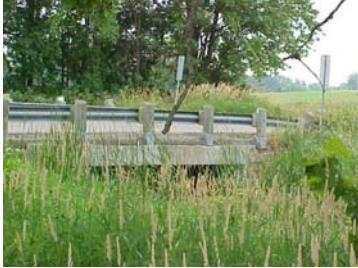
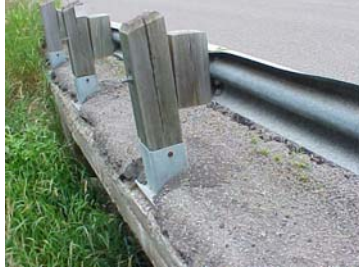
Bridge type: slab
Bride Management System Subtype: solid slab
No. of spans: single
Construction period: 1940-1955
Date if known:
Builder/engineer if known:
Construction material(s) and Details: This structure is composed of concrete. There is no obvious deterioration to this structure.
Integrity: There is some minor unsympathetic patchwork on the structure. A metal guard rail has been added to the structure.
Historical associations: There are no known associations for this structure.
Notes: This structure did not score well. The structure's design and lack of associations inhibited its heritage value.
Documentation: No written record for this structure was located.

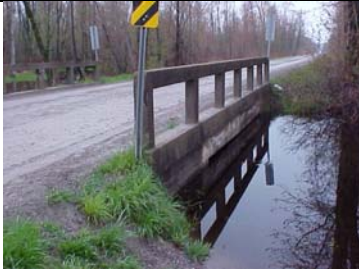
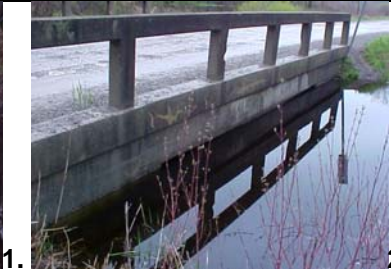
Construction material(s) and Details: This structure is composed of concrete and has a concrete balustrade. There is some minor deterioration to this structure.

2) south face

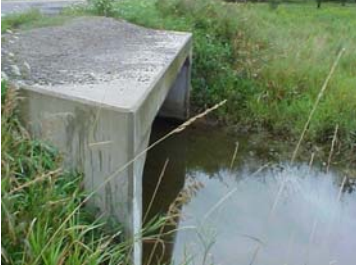
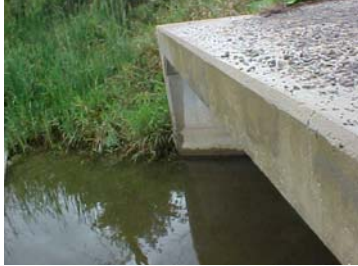
Bridge type: slab
Bride Management System Subtype: box-open footing
No. of spans: single
Construction period: 1940-1955
Date if known:
Builder/engineer if known:
Construction material(s) and Details: This structure is composed of concrete. There is no obvious deterioration to this structure.
Integrity: There is no evidence of alteration.
Historical associations: There are no known associations for this structure.
Notes: This structure did not score well. The structure's design and lack of associations inhibited its heritage value.
Documentation: No written record for this structure was located.

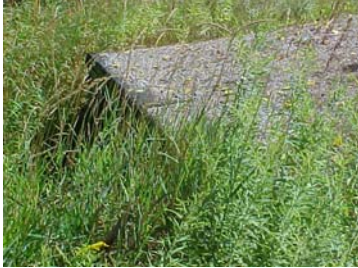
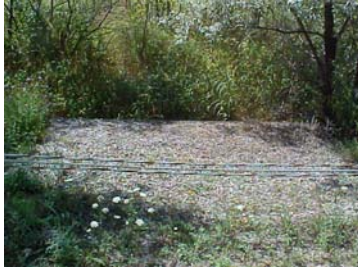
Construction material(s) and Details: This structure is composed of concrete. There is some obvious deterioration to this structure.

2) looking down on the south face

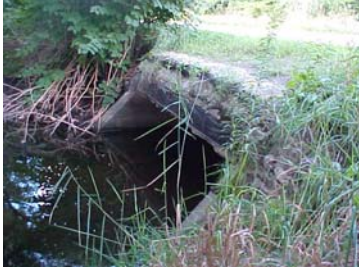
1.

Bridge type: slab
Bride Management System Subtype: box-open footing
No. of spans: single
Construction period: 1940-1955
Date if known:
Builder/engineer if known:
Construction material(s) and Details: This structure is composed of concrete. There is some obvious deterioration to this structure.
Integrity: There is much unsympathetic patchwork on the structure.
Historical associations: There are no known associations for this structure.
Notes: This structure did not score well. The structure's design, integrity, and lack of associations inhibited its heritage value.
Documentation: No written record for this structure was located.

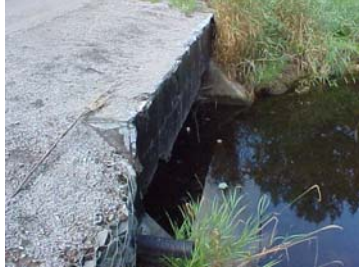
2.

Photos: 1) south face
2) north face

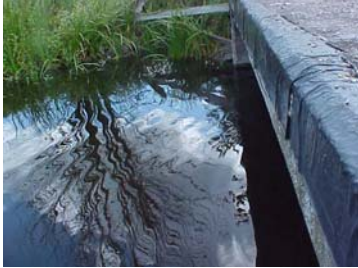
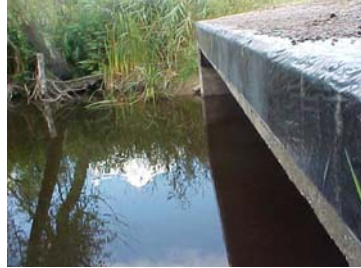
Bridge type: slab
Bride Management System Subtype: box-open footing
No. of spans: single
Construction period: 1940-1955
Date if known:
Builder/engineer if known:
Construction material(s) and Details: This structure is composed of concrete. There is little obvious deterioration to this structure.
Integrity: There is no evidence of alteration. A plastic tarp covers sections of the structure.
Historical associations: There are no known associations for this structure.
Notes: This structure did not score well. The structure's design, and lack of associations inhibited its heritage value.
Documentation: No written record for this structure was located.

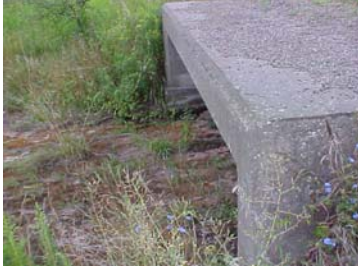
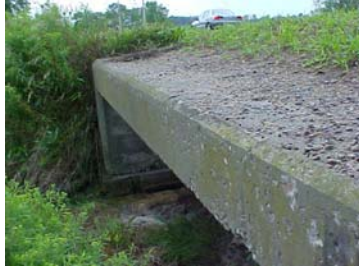
Asset/Bridge ID: 23-129
Street and crossing: Lynden Rd. – Fairchild Creek
Former Municipality(ies): Flamborough
UTM reference: E: 567650
N: 4793900
Date of survey: 19/08/02
Built heritage inventory file no: 60123
Heritage Evaluation Score and Grade: 31,D

Bridge type: slab
Bride Management System Subtype: solid slab
No. of spans: single
Construction period: 1940-1955
Date if known:
Builder/engineer if known:
Construction material(s) and Details: This structure is composed of concrete. There is little deterioration of the structure.
Integrity: There are no signs of alteration.
Historical associations: There are no known associations for this structure.
Notes: This structure did not score well. The structure's design, and lack of associations inhibited its heritage value.
Documentation: No written record for this structure was located.

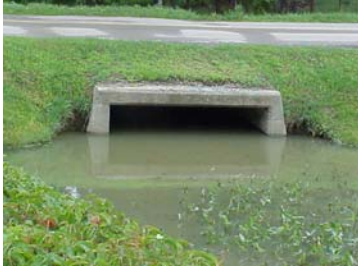
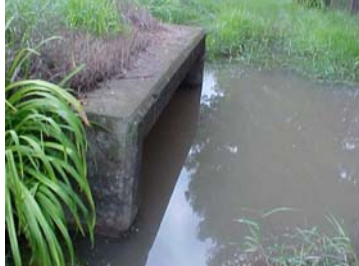
Bridge type: slab
Bride Management System Subtype: box, open footing
No. of spans: single
Construction period: 1940-1955
Date if known:
Builder/engineer if known:
Construction material(s) and Details: This structure is composed of concrete. There is no obvious deterioration of the structure.
Integrity: There is no evidence of alteration.
Historical associations: There are no known associations for this structure.
Notes: This structure did not score well. The structure's design, and lack of associations inhibited its heritage value.
Documentation: No written record for this structure was located.

Photos: 1) south face
2) north face

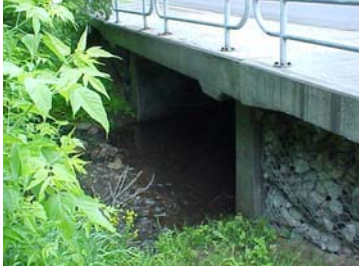
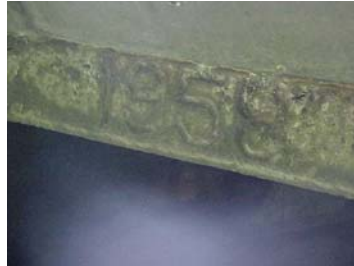
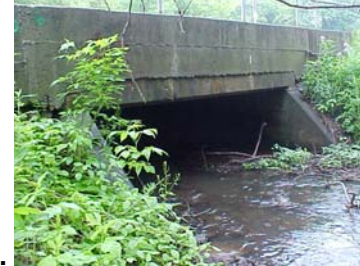
Construction material(s) and Details: This concrete box has two distinct appearances on its north and south faces. This is perhaps the result of a repair or refurbishing at some point in the structures history. The north side is has the construction date imprinted. It is unknown which side was constructed earliest if in fact it was done at two different times. The concrete deck as a steel balustrade.

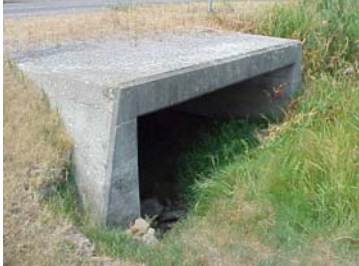
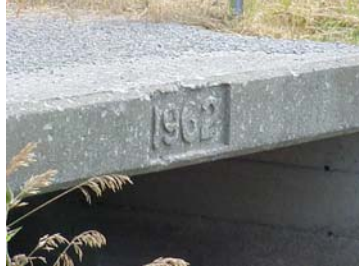
Construction material(s) and Details: This structure is composed of concrete. There is no obvious deterioration to this structure. The construction date is imprinted in the north deck face.

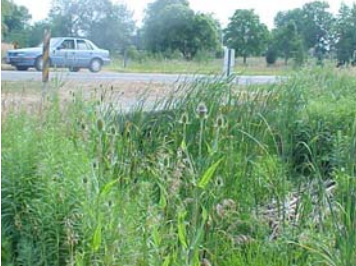
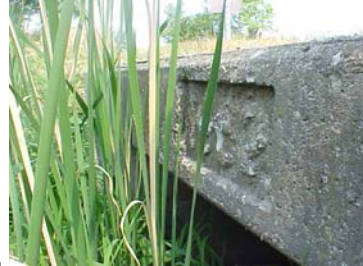
Construction material(s) and Details: This structure is composed of concrete. There is no obvious deterioration to this structure. The construction date is imprinted in the south deck face.

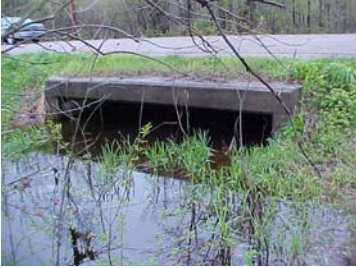
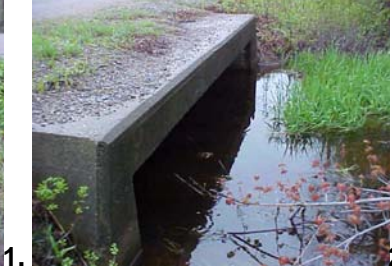
Asset/Bridge ID: 18-123
Street and crossing: Concession 5 W – Barlow creek
Former Municipality(ies): Flamborough
UTM reference: E: 571410
N: 4795605
Date of survey: 13/05/02
Built heritage inventory file no: 60118
Heritage Evaluation Score and Grade: 27,D

Bridge type: slab
Bride Management System Subtype: solid slab
No. of spans: single
Construction period: Post 1955
Date if known:
Builder/engineer if known:
Construction material(s) and Details: This structure is composed of concrete. There is little deterioration of the structure.
Integrity: There are no signs of alteration.
Historical associations: There are no known associations for this structure.
Notes: This structure did not score well. The structure's design, and lack of associations inhibited its heritage value.
Documentation: No written record for this structure was located.

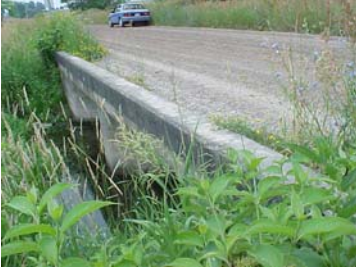
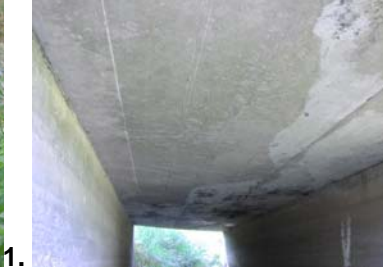
Bridge type: slab
Bride Management System Subtype: solid slab
No. of spans: single
Construction period: Post 1955
Date if known:
Builder/engineer if known:
Construction material(s) and Details: This structure is composed of concrete. There is little deterioration of the structure. A small concrete pier supports the deck.
Integrity: There are no signs of alteration.
Historical associations: There are no known associations for this structure.
Notes: This structure did not score well. The structure's design, and lack of associations inhibited its heritage value.
Documentation: No written record for this structure was located.

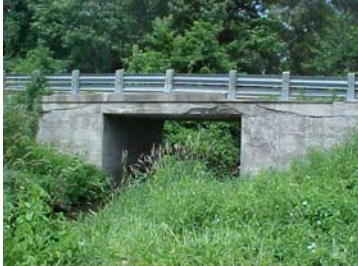
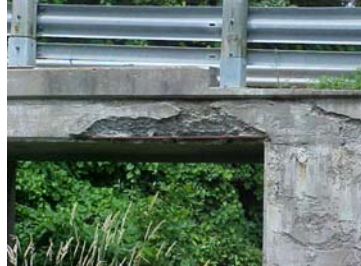
Construction material(s) and Details: This structure is composed of concrete. There is much obvious deterioration to this structure. The reinforcement is visible in some areas.

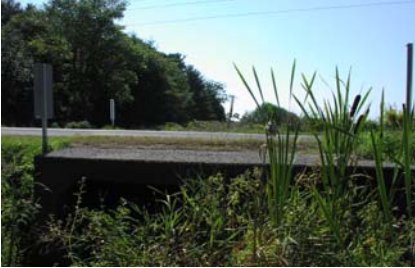
Bridge type: slab
Bride Management System Subtype: box
No. of spans: single
Construction period: Post 1955
Date if known:
Builder/engineer if known:
Construction material(s) and Details: This structure is composed of concrete. There is no obvious deterioration to this structure.
Integrity: There is no evidence of alteration.
Historical associations: There are no known associations for this structure.
Notes: This structure did not score well. The structure's design, and lack of associations inhibited its heritage value.
Documentation: No written record for this structure was located.

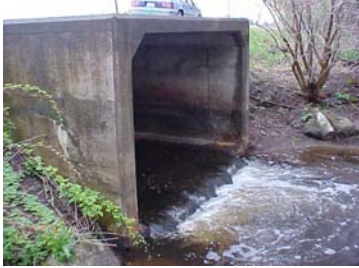
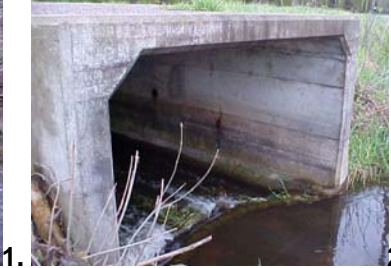
Bridge type: slab
Bride Management System Subtype: box-closed footing
No. of spans: single
Construction period: Post 1955
Date if known:
Builder/engineer if known:
Construction material(s) and Details: This structure is composed of concrete. There is no obvious deterioration to this structure.
Integrity: There is no evidence of alteration.
Historical associations: There are no known associations for this structure.
Notes: This structure did not score well. The structure's design, and lack of associations inhibited its heritage value.
Documentation: No written record for this structure was located.

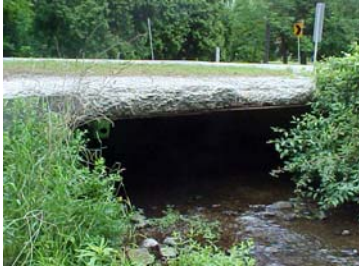
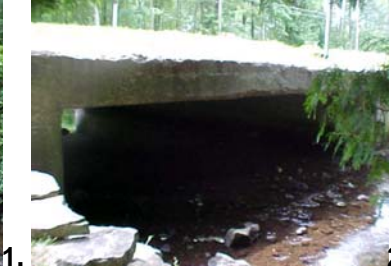
Bridge type: slab
Bride Management System Subtype: solid slab
No. of spans: single
Construction period: Post 1955
Date if known:
Builder/engineer if known:
Construction material(s) and Details: This structure is composed of concrete. There is some obvious deterioration to this structure.
Integrity: There is no evidence of alteration.
Historical associations: There are no known associations for this structure.
Notes: This structure did not score well. The structure's design and lack of associations inhibited its heritage value.
Documentation: No written record for this structure was located.

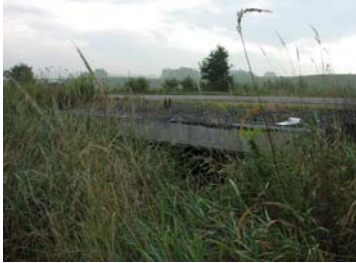
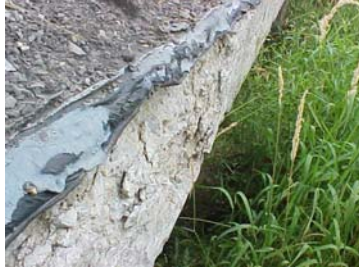
Construction material(s) and Details: This structure is composed of concrete. There is some obvious deterioration to this structure.

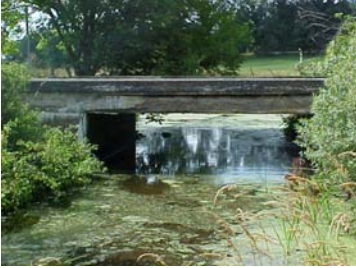
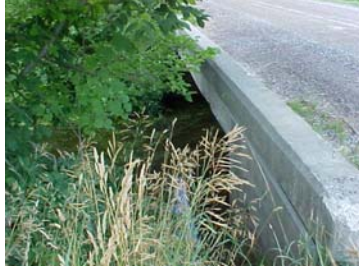
Construction material(s) and Details: This structure is composed of concrete. There is some obvious deterioration to this structure.

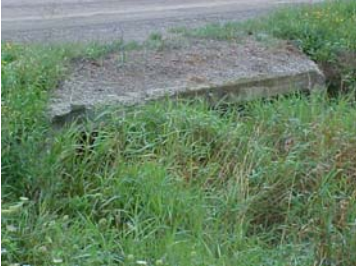
Bridge type: slab
Bride Management System Subtype: solid slab
No. of spans: single
Construction period: Post 1955
Date if known:
Builder/engineer if known:
Construction material(s) and Details: This structure is composed of concrete. There is some obvious deterioration to this structure.
Integrity: There is no evidence of alteration.
Historical associations: There are no known associations for this structure.
Notes: This structure did no score well. It did not score points relative to its design, historic, and aesthetics characteristics.
Documentation: No written record for this structure was located.

Photos: 1) East face

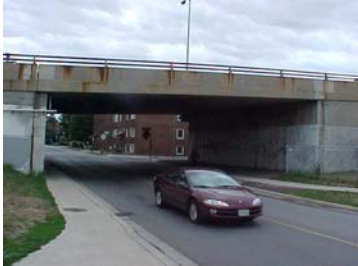
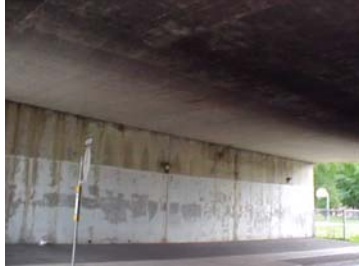
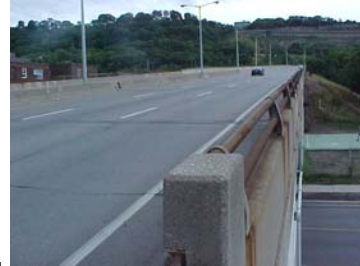
Construction material(s) and Details: This structure is composed of concrete and has a simple, steel balustrade. There is some obvious deterioration to both the steel and concrete components of this structure.

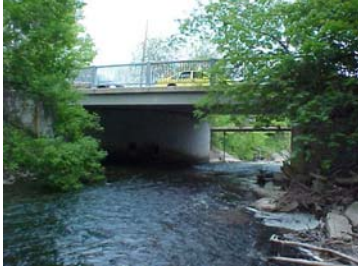
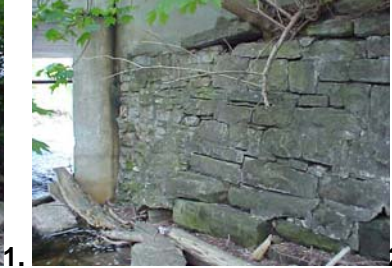
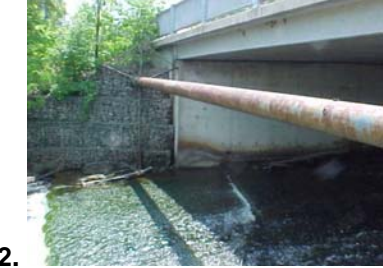
Construction material(s) and Details: This concrete structure has a simple, steel balustrade. Located next to the present abutments are the remnants of what is suspected to be a former bridge that spanned this site.

Photos: 1) West face
2) Remnants of former bridge
3) West face

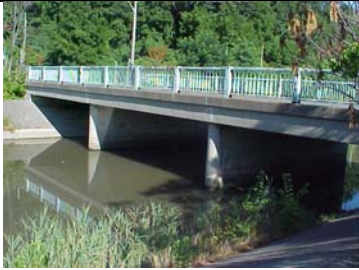
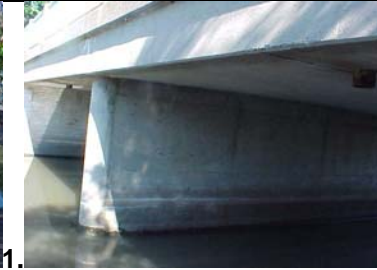
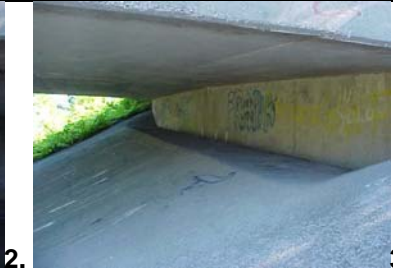
Construction material(s) and Details: This concrete structure has concrete piers that carry a continuous span across the stream. The deck has a simple, steel balustrade.

Photos: 1) South face
2) Piers
3) East Abutment

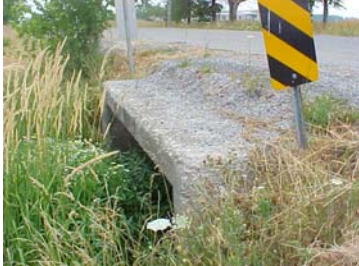
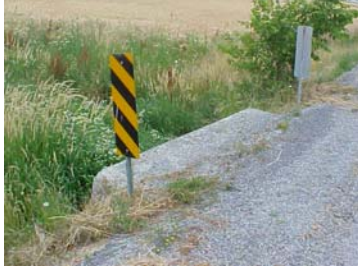
Construction material(s) and Details: This structure is composed of concrete. There is some obvious deterioration to this structure.

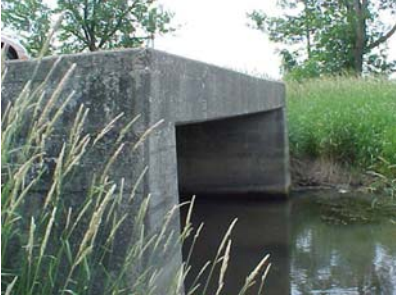
Photos: 1) North face

Asset/Bridge ID: 421-0020
Street and crossing: Hendershot – Sinkhole creek
Former Municipality(ies): Glanbrook
UTM reference: E:600710
N:4779280
Date of survey: 2/7/02
Built heritage inventory file no: 601421
Heritage Evaluation Score and Grade: 27,D

Bridge type: slab
Bride Management System Subtype: Solid Slab
No. of spans: single
Construction period: post-1955
Date if known:
Builder/engineer if known:
Construction material(s) and Details: This structure is composed of concrete.
Integrity: There is no evidence of alteration.
Historical associations: There are no known historical associations.
Notes: This structure scored high on integrity, but low overall. It did not score for uniqueness or historical association.
Documentation: A written record for the structure was not located.

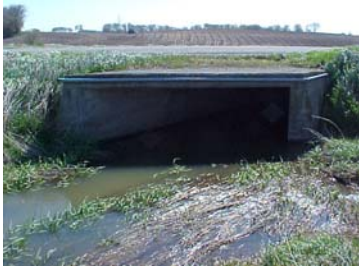
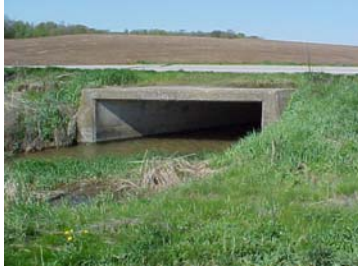
Asset/Bridge ID: 107-0014
Street and crossing: Field Road –Big Creek
Former Municipality(ies): Ancaster
UTM reference: E:578505
N:4784690
Date of survey: 10/5/02
Built heritage inventory file no: 601107
Heritage Evaluation Score and Grade: 27,C

Bridge type: slab

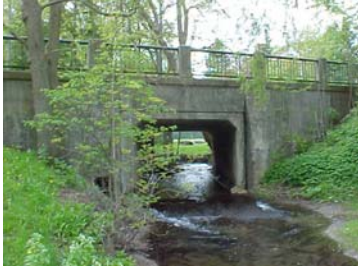
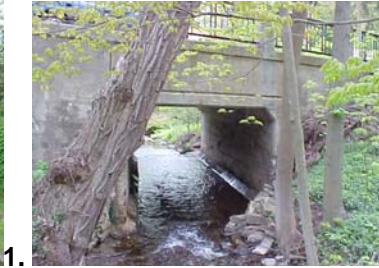
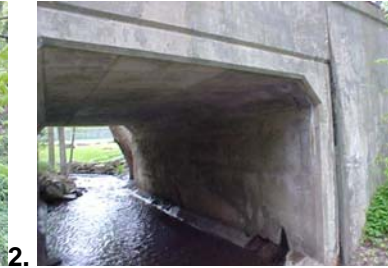
Bridge type: slab
Bride Management System Subtype: Box, closed footing
No. of spans: 1
Construction period: Post 1955
Date if known:
Builder/engineer if known:
Construction material(s) and Details: This concrete box has decorative cuts in the concrete superstructure. It also has a simple, decorative balustrade. The steel reinforcement is visible in some spots but there is no other significant deterioration.
Integrity: There is little patchwork on the structure and no obvious signs of alteration.
Historical associations: There are no known historical associations for this structure.
Notes: This structure scored low on the heritage evaluation. It did not score well because its lack of historical associations. It also scored low for being a relatively young concrete structure.
Documentation: A written record for the structure was not located.

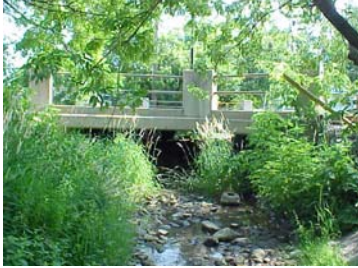
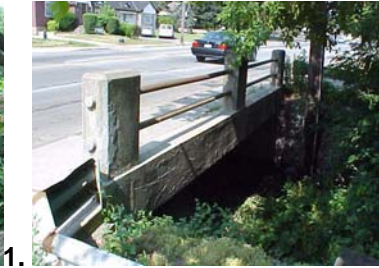
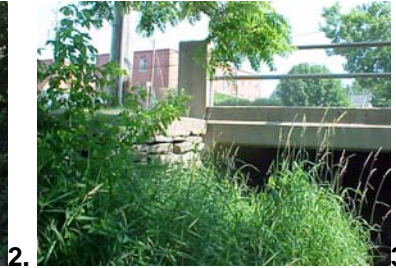
Photos: 1) West face
2) East face
3) West face-close

Asset/Bridge ID: 367-4007
Street and crossing: King Street East-Stoney Creek
Former Municipality(ies): Stoney Creek
UTM reference: E:601210
N:4785800
Date of survey: 4/7/02
Built heritage inventory file no: 601367
Heritage Evaluation Score and Grade: 25,C

Bridge type: slab

Bride Management System Subtype: solid slab

Historical associations: This structure is of close proximity to the Battlefield Park historic site, but no know historical associations for the structure could be found.

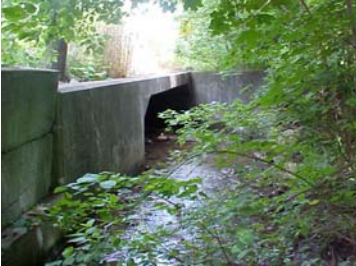
Asset/Bridge ID: 116-0023
Street and crossing: Lower Lions Club Rd.-Ancaster Creek
Former Municipality(ies): Ancaster
UTM reference: E:583980
N:4788205
Date of survey: 25/7/02
Built heritage inventory file no: 601116
Heritage Evaluation Score and Grade: 27,C

Bridge type: slab
Bride Management System Subtype: box, open footing
No. of spans: 1
Construction period: Post-1955
Date if known:
Builder/engineer if known:
Construction material(s) and Details: This simple concrete box has wing walls on the north ends of both faces. The wing wall on the south end of the east face extends downstream and meets with concrete blocks that prevent the erosion of the roadway.
Integrity: There is no evidence of alteration.
Historical associations: There are no known historical associations.
Notes: This structure scored low on the heritage evaluation. It did not score well because its lack of historical associations. It also scored low for being a relatively young concrete structure. It scored well on integrity—having no known material modifications.
Documentation: A written record for the structure was not located.
Photos: 1) East face
