Heritage Structure Assessment

This assessment is the resulting product of a heritage study on bridge structures in the City of Hamilton. The study and the assessment were conducted from May to August 2002. The aim was to establish a heritage record for all bridge structures over the age of 35 years. The assessment is a required component of the Class Environmental Assessment that will be conducted on the city's bridge structures later in 2002. The Environmental Assessment Act mandates the heritage data will be considered in any final decisions that may impact the nature of a structure.

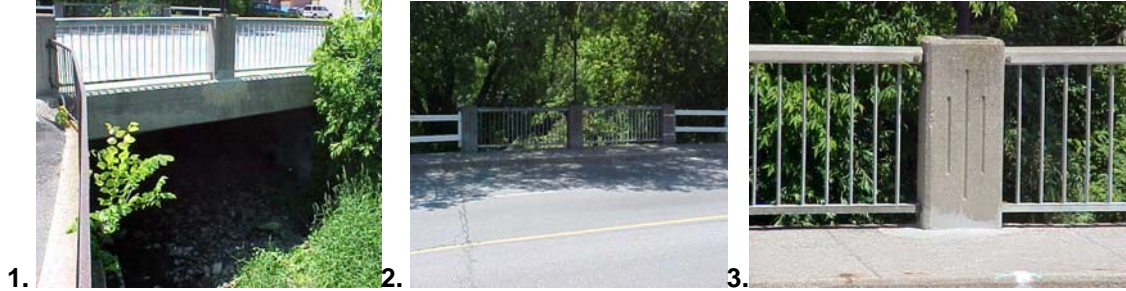
Photos: 1) South face
2) North balustrade
3) South balustrade

Asset/Bridge ID: 368/4006
Street and crossing: King St. – Stoney Creek
Former Municipality(ies): Stoney Creek
UTM reference: E: 601140
N: 4785620
Date of survey: 6/18/02
Built heritage inventory file no: 601368
Heritage Evaluation Score and Grade: 30, D

Bridge type: slab

Bride Management System Subtype: Solid Slab

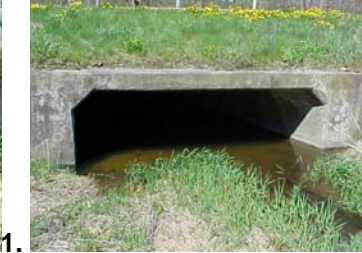
Photos: 1) West face
2) East face

Asset/Bridge ID: 110/0017
Street and crossing: Weir Rd- Fairchild Creek
Former Municipality(ies): Ancaster
UTM reference: E:567450
N:4784440
Date of survey: 10/5/02
Built heritage inventory file no: 601110
Heritage Evaluation Score and Grade: 27, D

Bridge type: slab
Bride Management System Subtype: Box, open footing
No. of spans: single
Construction period: post-1955
Date if known:
Builder/engineer if known:
Construction material(s) and Details: This structure is composed of concrete. It is mounted by approximately 60cm of fill/grading.
Integrity: There is no evidence of alteration.
Historical associations: This structure has no known historical associations.
Notes: This structure scored high on integrity. However it scored low overall due to lack of historical associations and uniqueness.
Documentation: A written record for the structure was not located.

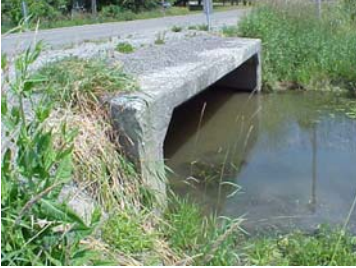
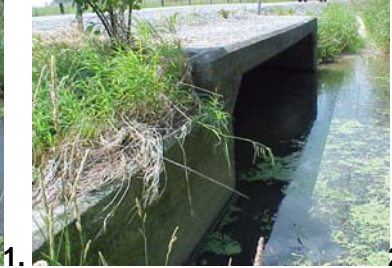
Photos: 1) West face
2) East face

Asset/Bridge ID: 53-003205
Street and crossing: Third Road East-Stoney Creek
Former Municipality(ies): Stoney Creek
UTM reference: E:602320
N:4781550
Date of survey: 2/7/02
Built heritage inventory file no: 60153
Heritage Evaluation Score and Grade: 27,C

Bridge type: slab
Bride Management System Subtype: box, closed footing
No. of spans: 1
Construction period: Post 1955
Date if known:
Builder/engineer if known:
Construction material(s) and Details: This simple concrete box has one wing wall that extends north on the west face.
Integrity: There is no evidence of alteration.
Historical associations: There are no known historical associations.
Notes: This structure scored low on the heritage evaluation. It did not score well because its lack of historical associations. It also scored low for being a relatively young concrete structure. It scored well on integrity—having no known material modifications.
Documentation: A written record for the structure was not located.

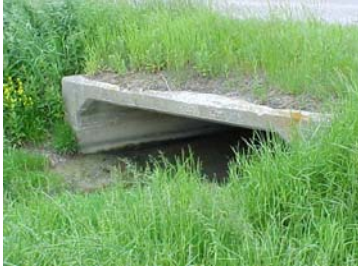
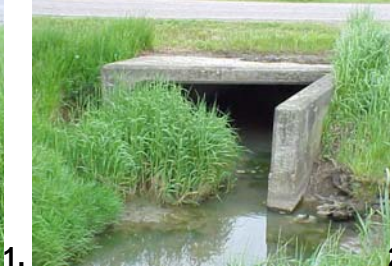
Photos: 1) West face
2) East face

Asset/Bridge ID: 103-0010
Street and crossing: Butter Road- Big Creek
Former Municipality(ies): Ancaster
UTM reference: E:580940
N:4779210
Date of survey: 6/6/02
Built heritage inventory file no: 601103
Heritage Evaluation Score and Grade: 27,C

Bridge type: slab
Bride Management System Subtype: box, open footing
No. of spans: 1
Construction period: Post 1955
Date if known:
Builder/engineer if known:
Construction material(s) and Details: This simple concrete box has a single wing wall that extends from the west face.
Integrity: There is no evidence of alteration.
Historical associations: There are no known historical associations.
Notes: This structure scored low on the heritage evaluation. It did not score well because its lack of historical associations. It also scored low for being a relatively young concrete structure. It scored well on integrity—having no known material modifications.
Documentation: A written record for the structure was not located.

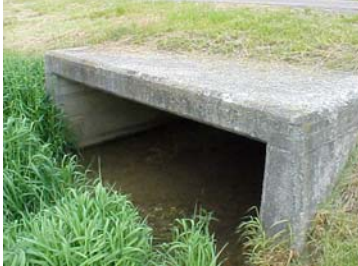
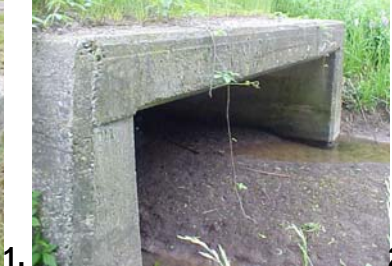
Bridge type: slab
Bride Management System Subtype: solid slab
No. of spans: 1
Construction period: Post 1955
Date if known:
Builder/engineer if known:
Construction material(s) and Details: This simple concrete box shows no signs of deterioration.
Integrity: There is no evidence of alteration.
Historical associations: There are no known historical associations.
Notes: This structure scored low on the heritage evaluation. It did not score well because its lack of historical associations. It also scored low for being a relatively young concrete structure. It scored well on integrity—having no known material modifications.
Documentation: A written record for the structure was not located.

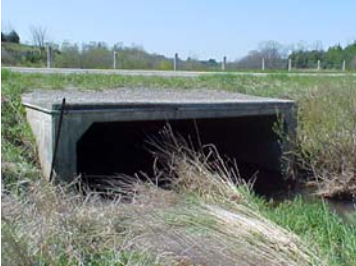
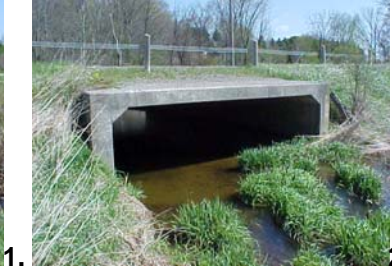
Bridge type: slab
Bride Management System Subtype: box, open footing
No. of spans: 1
Construction period: Post 1955
Date if known:
Builder/engineer if known:
Construction material(s) and Details: This simple concrete box shows no signs of deterioration.
Integrity: There is no evidence of alteration.
Historical associations: There are no known historical associations.
Notes: This structure scored low on the heritage evaluation. It did not score well because its lack of historical associations. It also scored low for being a relatively young concrete structure. It scored well on integrity—having no known material modifications.
Documentation: A written record for the structure was not located.

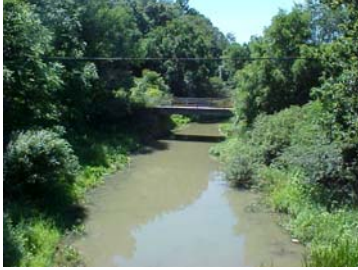
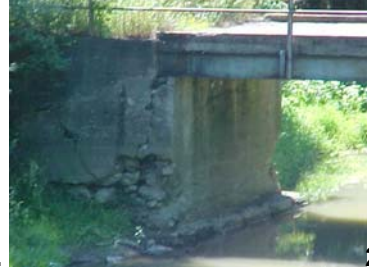
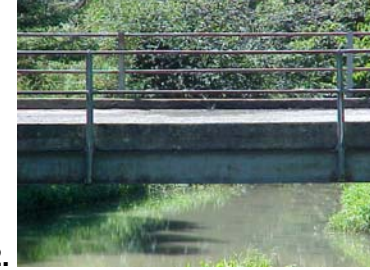
Asset/Bridge ID: N/A
Street and crossing: Former Hall Rd.
Former Municipality(ies): Glanbrook
UTM reference: E:
N:
Date of survey:
Built heritage inventory file no:
Heritage Evaluation Score and Grade: 35,D

Bridge type: beam
Bride Management System Subtype: N/A
No. of spans: single
Construction period: 1901-1939
Date if known:
Builder/engineer if known:

Construction and Material Details: *Concrete abutments support this steel beam bridge. All components of this structure show many signs of deterioration. A simple steel balustrade runs along the deck of the structure.*

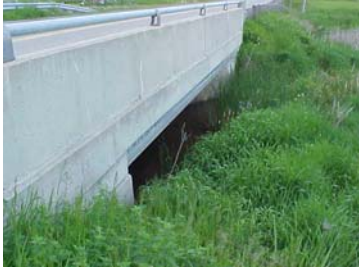
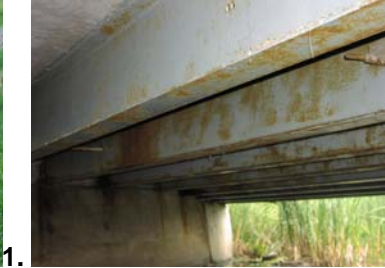
Heritage Evaluation Score and Grade: This structure was not graded because it is not believed it meets the 35-year age qualifier for assessment.

Bridge type: beam

Bride Management System Subtype: I-beams

Notes: This structure was listed as being constructed in 1935. This is obviously not the case. No information could be found that identified when it was reconstructed.

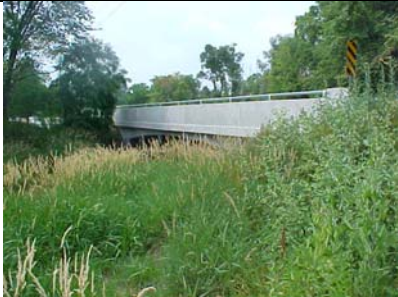
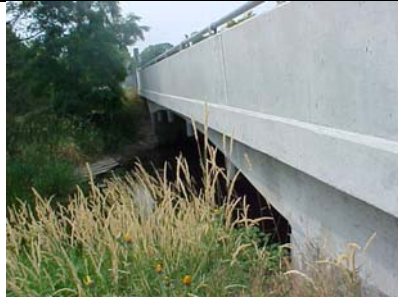
Heritage Evaluation Score and Grade: This structure was not graded because it is not believed it meets the 35-year age qualifier for assessment.

Bridge type: rigid frame

Notes: This structure was listed as being constructed in 1950. This is not believed to be the case. No information could be found that identified when it was reconstructed.

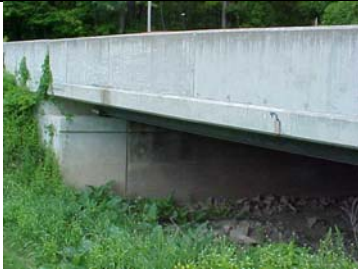
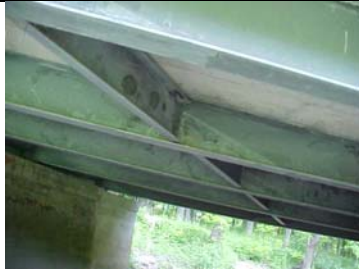
Heritage Evaluation Score and Grade: This structure was not graded because it is not believed it meets the 35-year age qualifier for assessment.

Bridge type: rigid frame

Notes: This structure was listed as being constructed in 1930. This is not believed to be the case. No information could be found that identified when it was reconstructed.

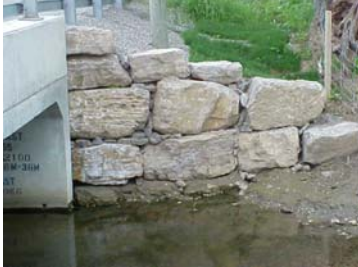
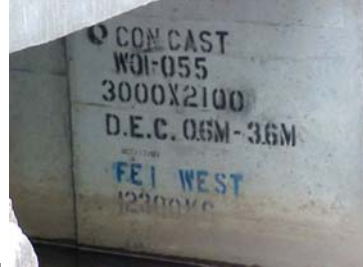
Heritage Evaluation Score and Grade: This structure was not graded because it is not believed it meets the 35-year age qualifier for assessment.

Bridge type:

Notes: This structure was listed as being constructed in 1928. This is not believed to be the case. No information could be found that identified when it was reconstructed.

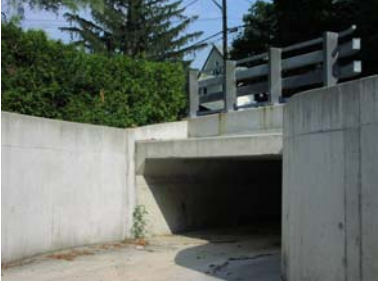
Heritage Evaluation Score and Grade: This structure was not graded because it is not believed it meets the 35-year age qualifier for assessment.

Bridge type:

Notes: This structure was listed as being constructed in 1940. This is not believed to be the case. No information could be found that identified when it was reconstructed.
